Lead Cable Investigation

June 30, 2023

Tom Neltner
Environmental Defense Fund
1875 Connecticut Ave NW
Washington, D.C. 20009

Marine Taxonomic Services, Ltd.
Below the Blue 501(c)3

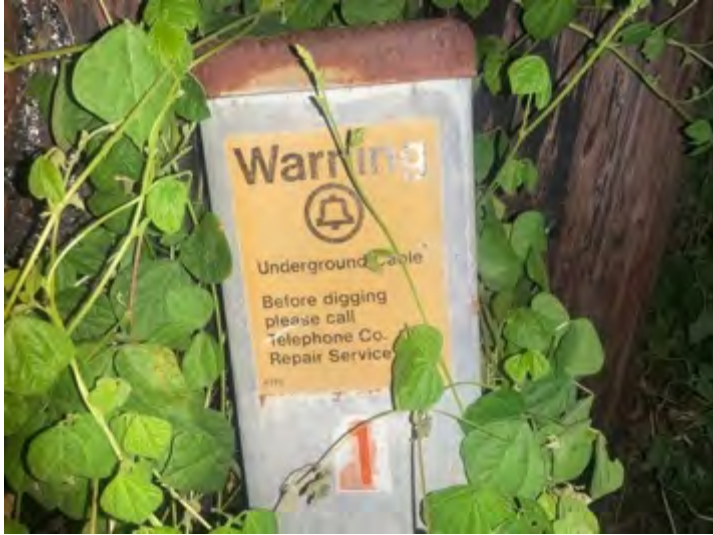
(A) Bell Systems sign for underground Telephone Cables. BL 2.1. Labadieville, Louisiana. June 2022.

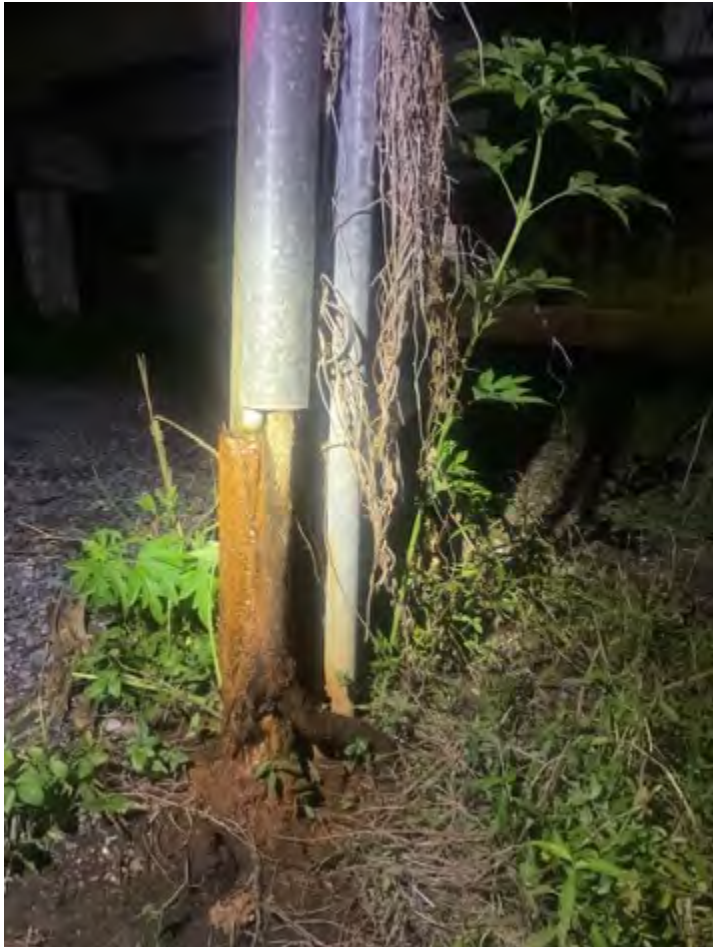
(B) Old telephone pole with cable guard and old conduit where a cable would have been. There is currently corrugated plastic hose behind the guard and in the steel pipe, but no visible cable. BL 2.2. Labadieville, Louisiana. June 2022.

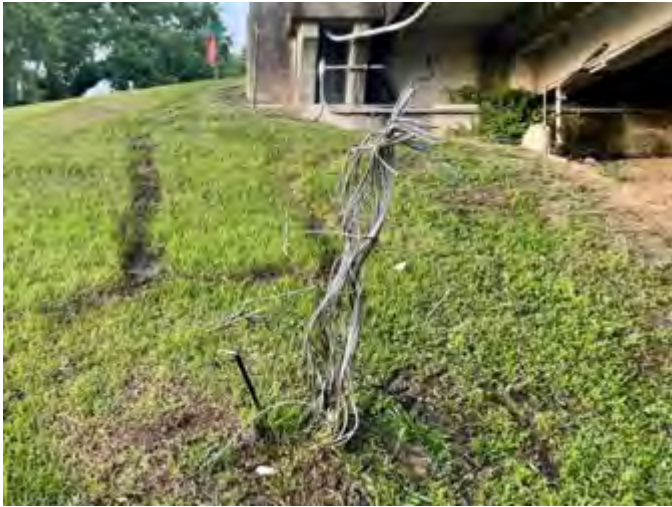
(C) Remnants of bare lead sheathed cable and steel wire below the Bridge Street Bridge. BT 1.1. June 2022, New Iberia, Louisiana.

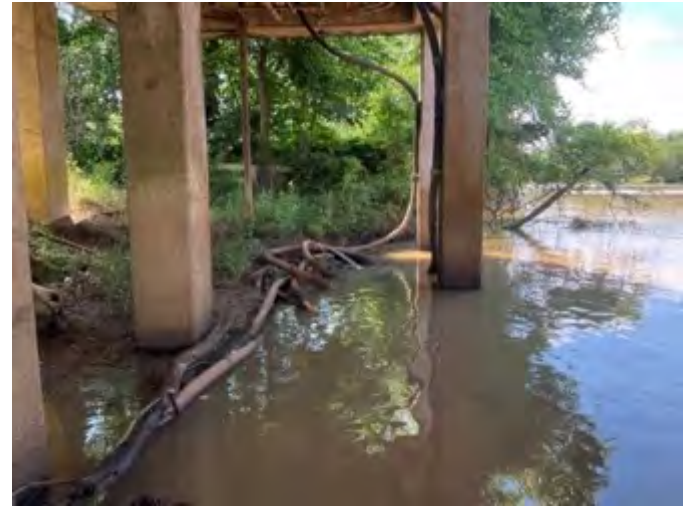
(E) Rd. 320 southeast of New Iberia, LA. Cluster of lead sheathed cables under the Oliver Bridge. BT 17.1. June 2022, New Iberia, Louisiana.

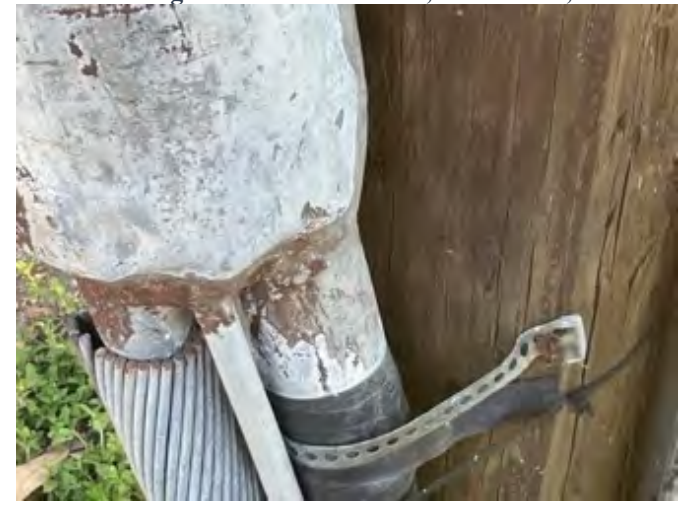
(F) Up close photo of bare lead sheathed cables coming from the bottom of a lead splice box (upper left corner of photo). BT 24.1. June 2022, St. Martinville, Louisiana.

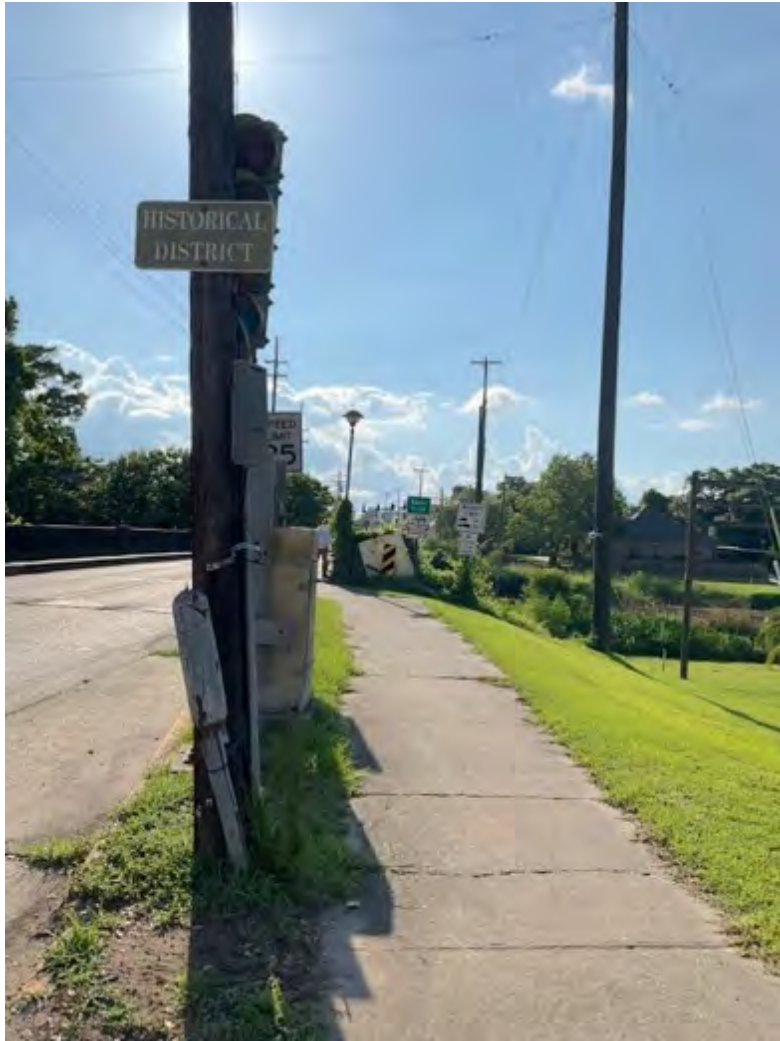
(G) Bare lead sheathed cables going into a lead splice box near the sidewalk leading into the Historical District. BT 24.1. June 2022, St Martinville, Louisiana.

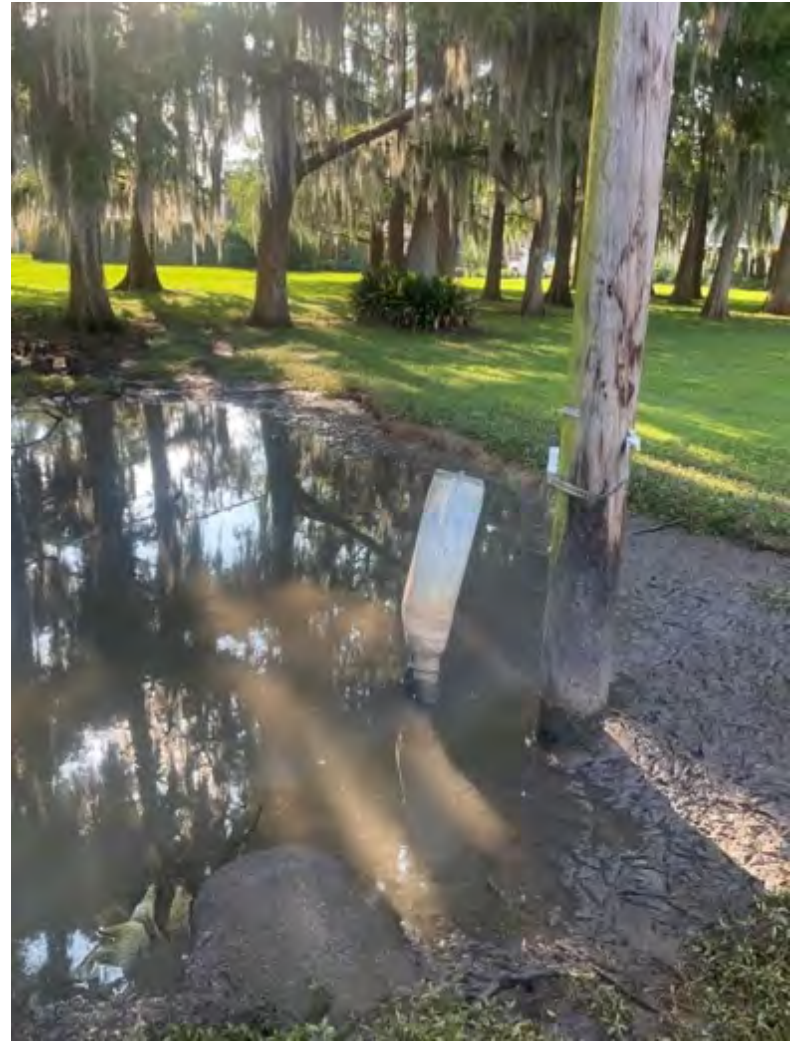
(H) Exposed lead splice box with attached cables and drainage into the Bayou Teche. BT 26.2. June 2022, Franklin, Louisiana.

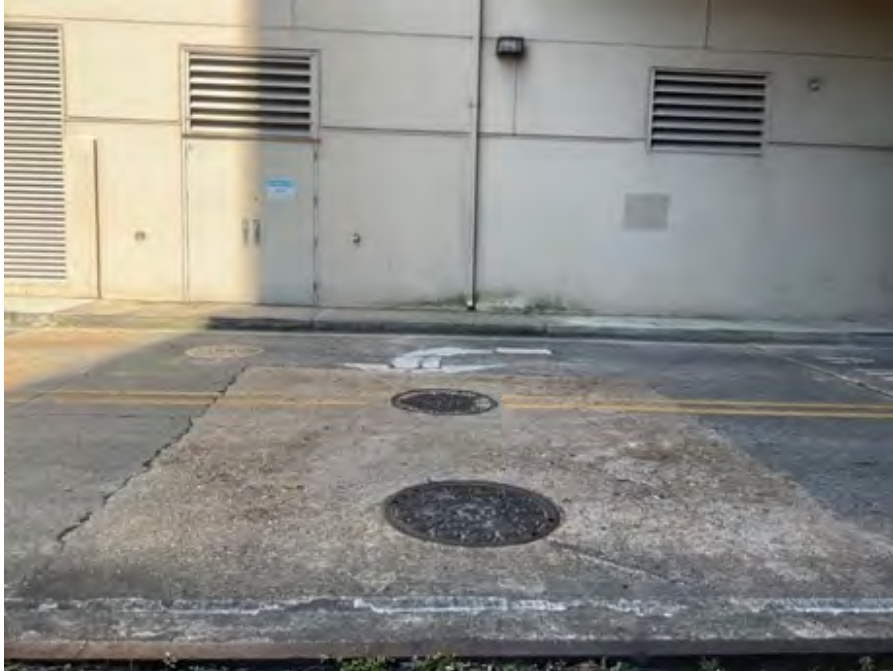
(I) New Orleans, LA. MISS 2.1 with Bell Systems manholes, vault, and Utility Building. This is a likely hub and splice area for cables, both old and new. June 2022.

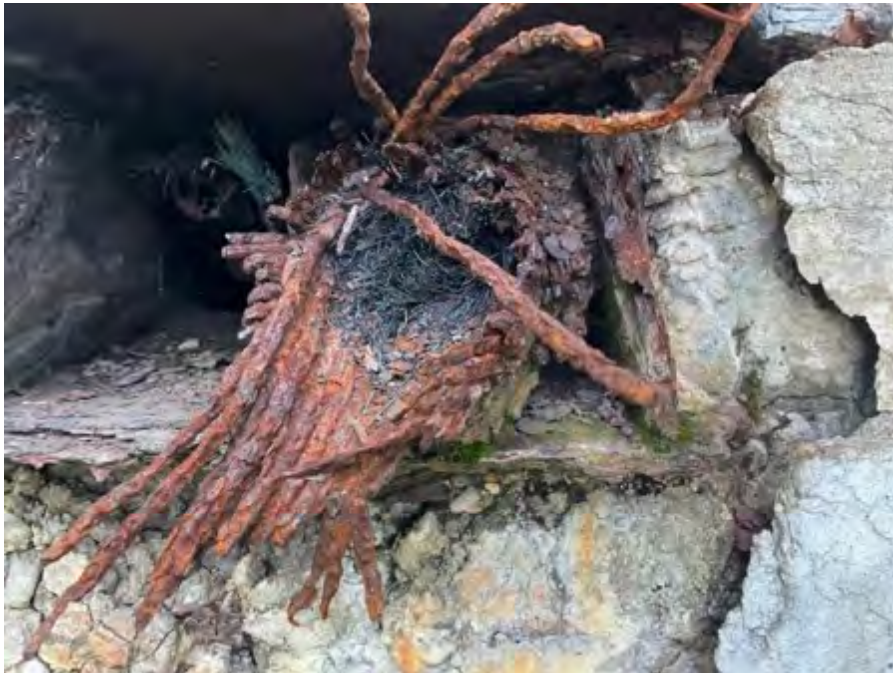
(J) New Orleans, LA. MISS 3.1. is an abandoned collection of cables.

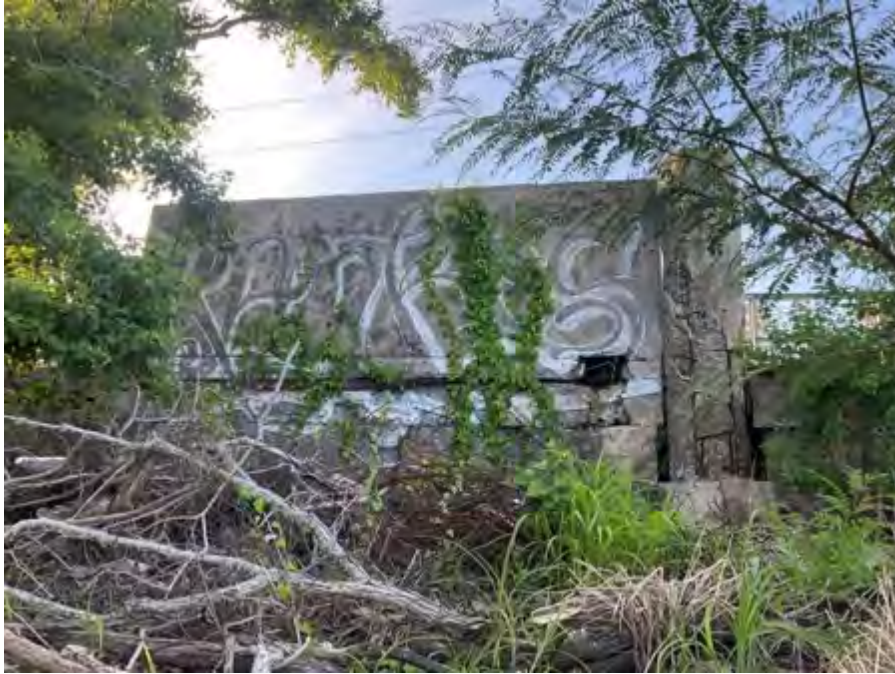
(K) New Orleans, LA. MISS 3.1. The small rectangle on the left is the passthrough for utility cables. June 2022.

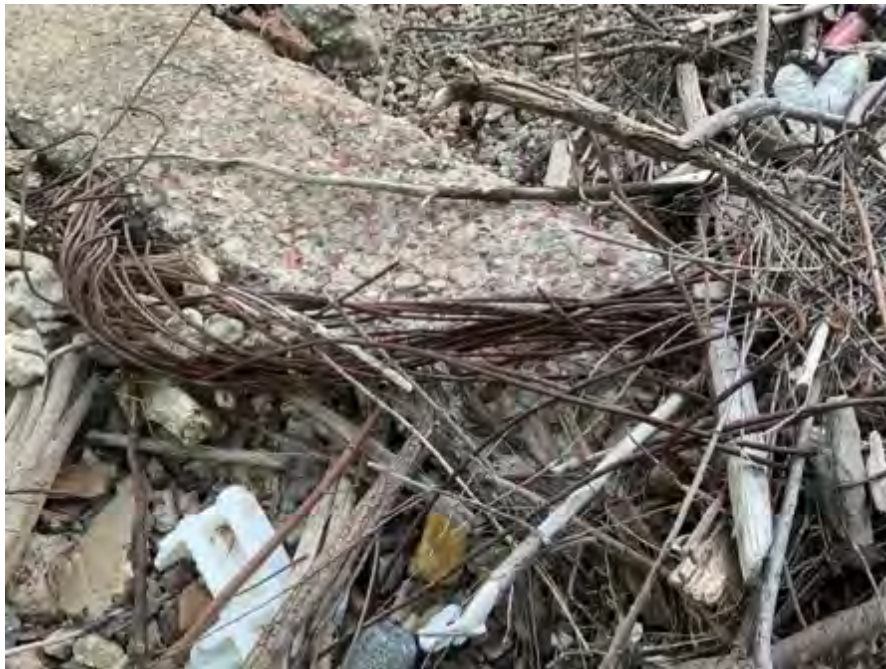
(L) New Orleans, LA. MISS 3.1. Remnants of outer steel wire from a lead sheathed cable. Evidence that parts of the cable may have been scrapped for money. Locals told us that that was done to these cables.

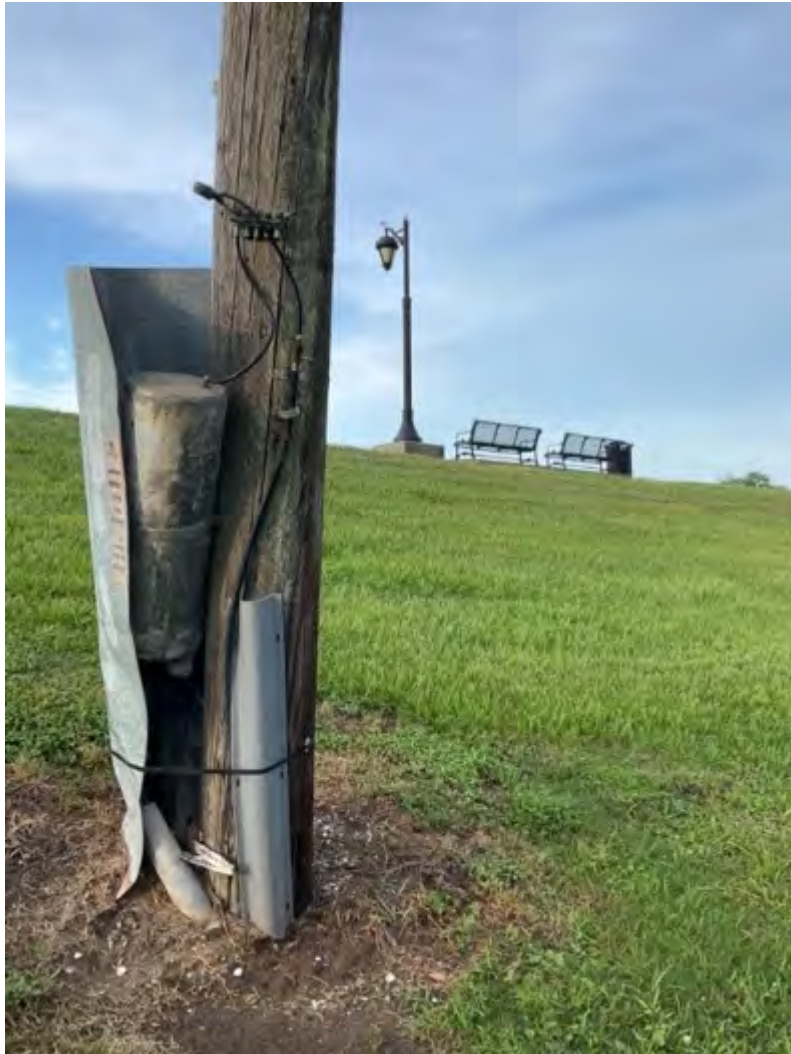
(M) Donaldsonville, LA. Location MISS 12.1. Exposed leaded splice box that appears to still be connected to an air test line. See photo (L) for the abandoned cable just the other side of the splice box. June 2022,

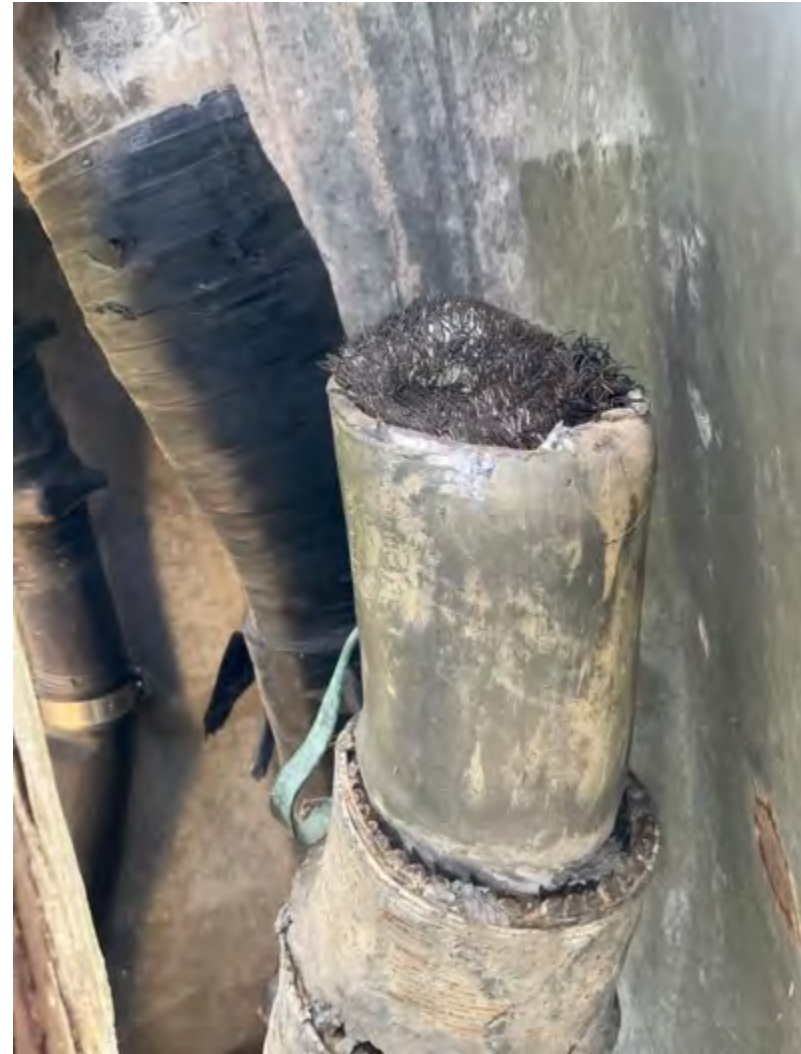
(N) Donaldsonville, LA. Location MISS 12.1. Close up of lead sheathed cable next to lead splice box seen in (K). June 2022.

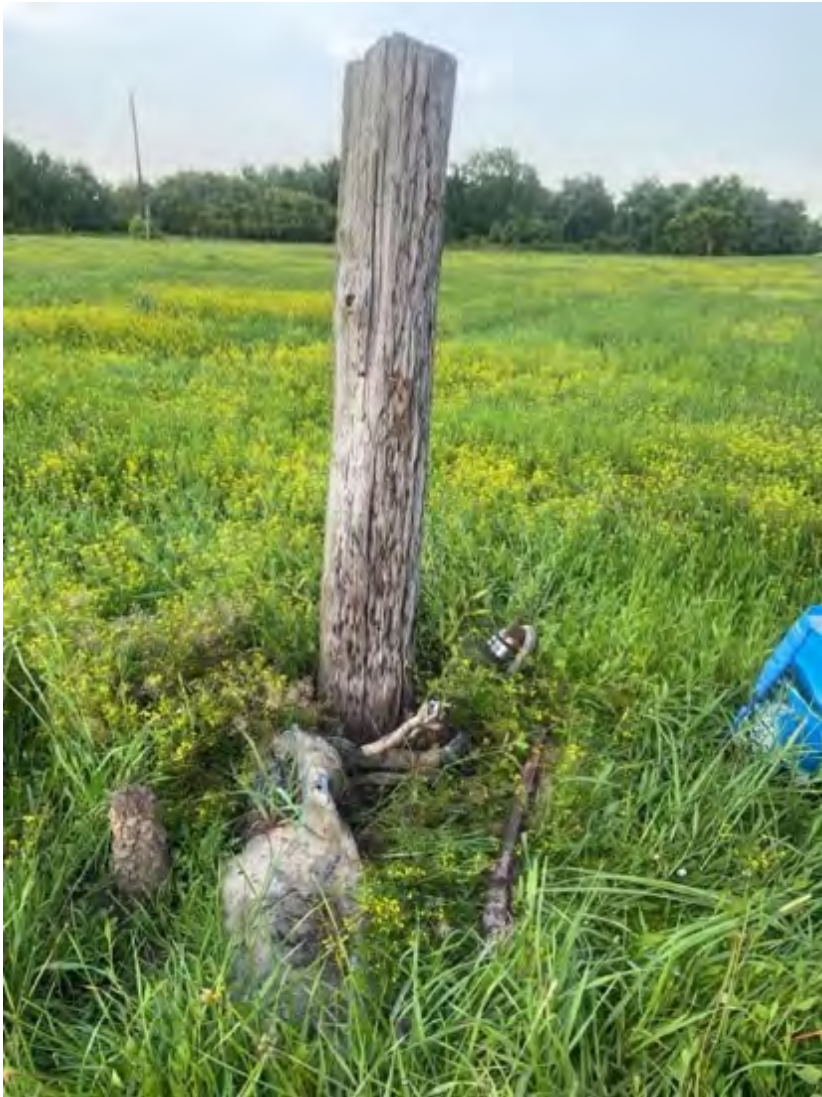
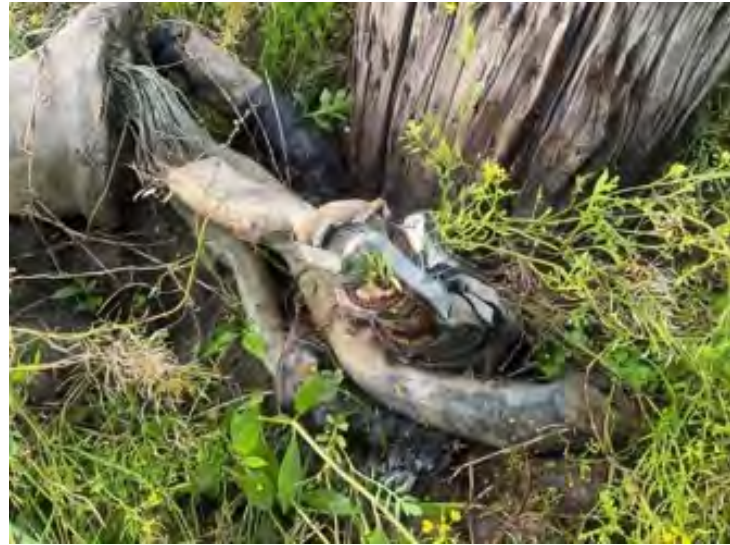
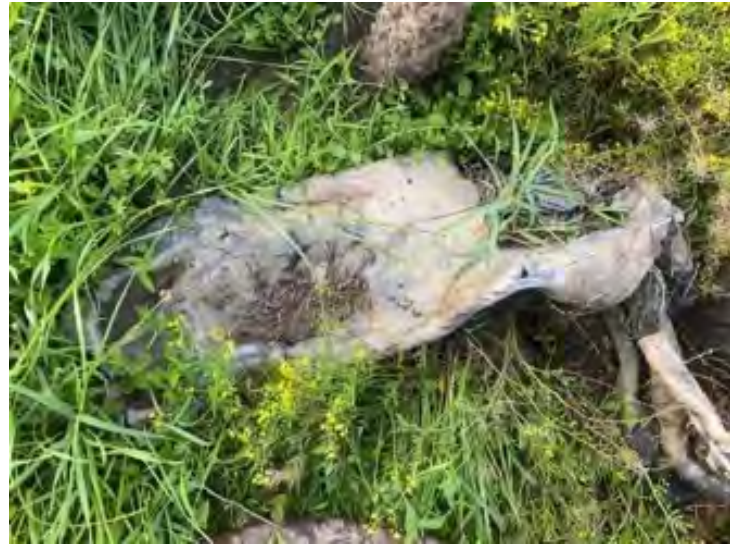
Figure 9 Photos. Louisiana continued. Damaged and abandoned leaded splice box and collection of five lead sheathed cables. MISS 12.3. June 2022, Donaldsonville, Louisiana.

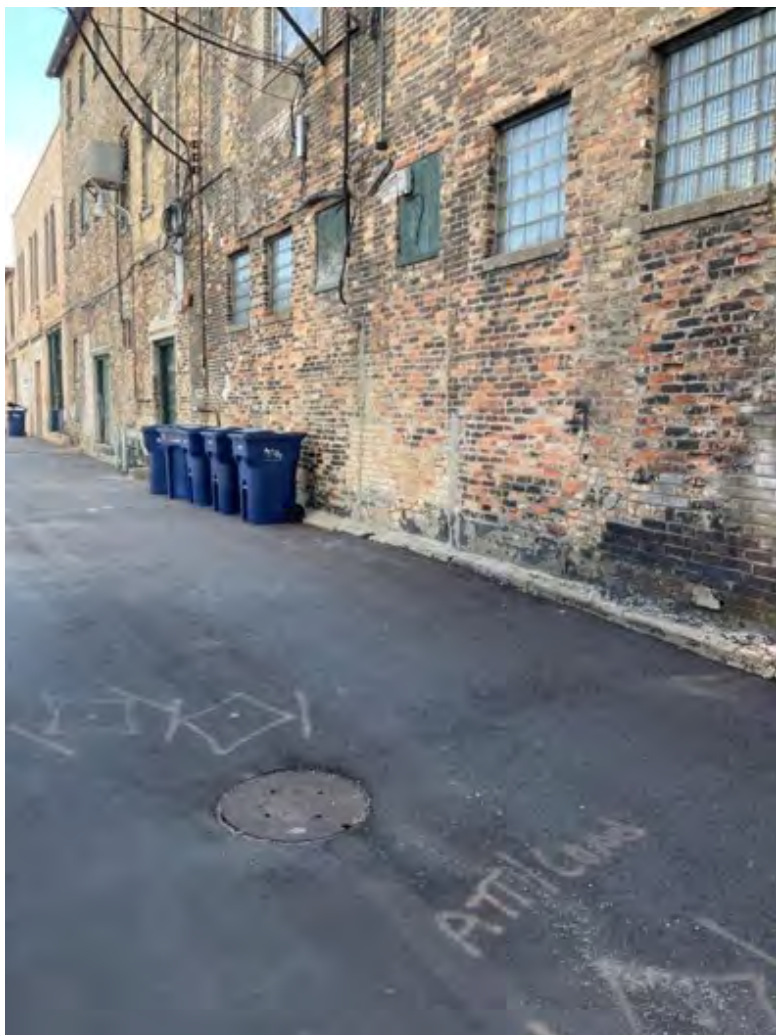
(A) Paint Markings indicating an AT&T service corridor. The lead sheathed test line follows these markings along the brick building shown above. LH 2.2. July 2022, Bay City, MI.

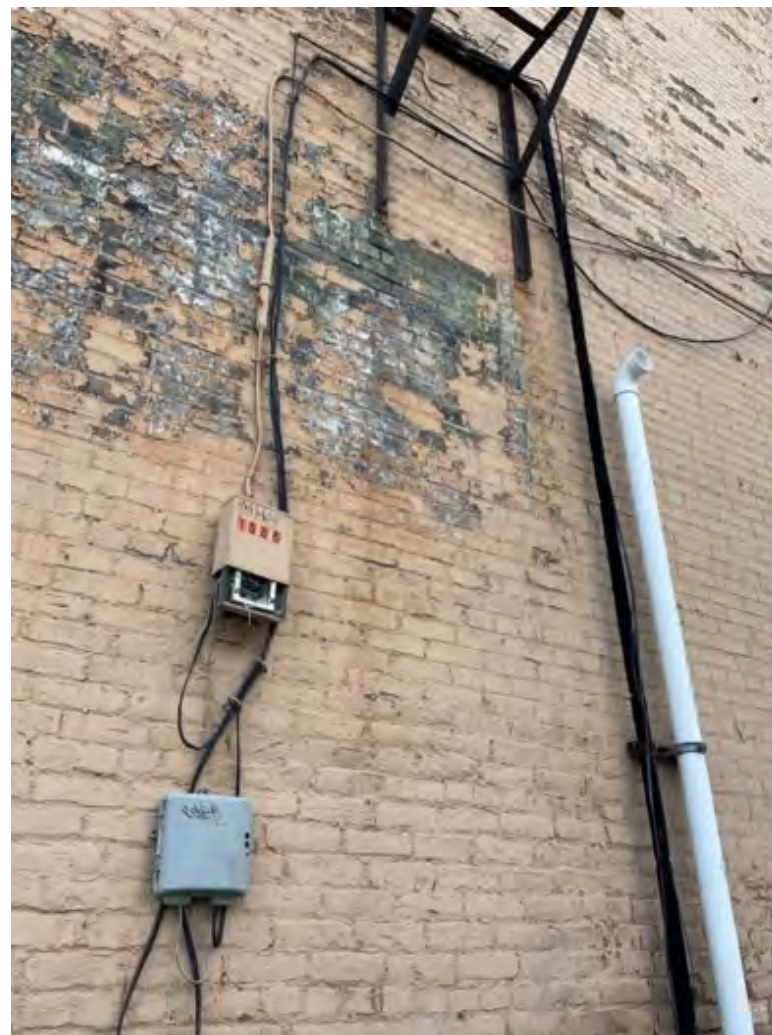
(B) End of the lead sheathed test line shown in (A). LH 2.3. July 2022, Bay City, MI.

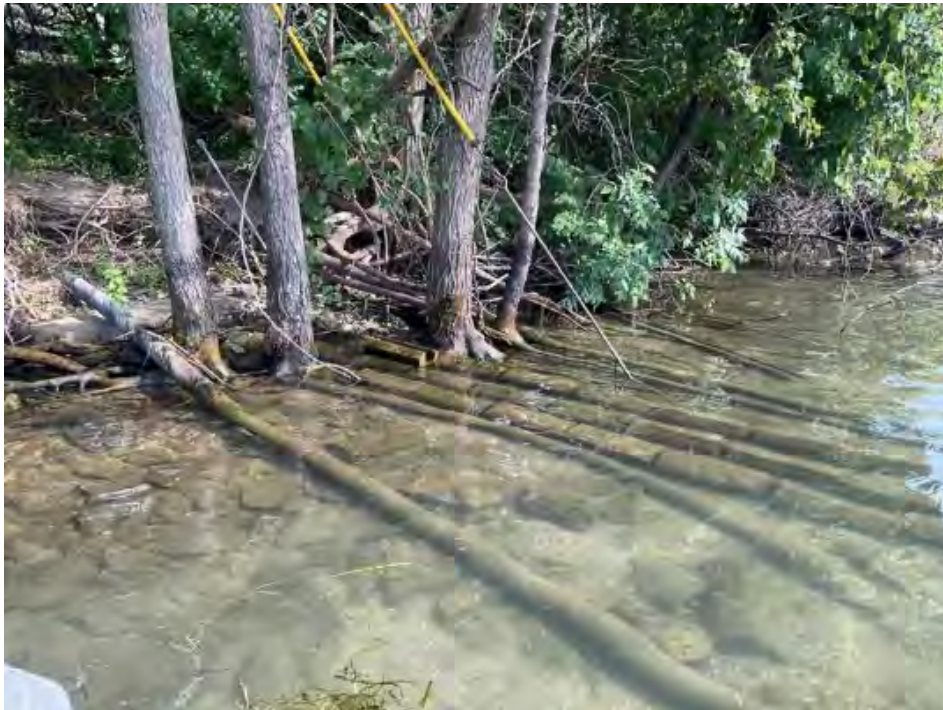
The only two locations in the screening areas contain visible lead sheathed cables along the Detroit River. At Location DR 1, there were seven cables along the shoreline and two Bell Systems manholes near the road (Figure 11(C-D)). The other location with a single cable hanging from the bridge and going into the water was found at site DR 2 (Figure 12(E-F)). The cable was cut and clearly abandoned in place. DR 3 was a sampled water intake location. For additional information, refer to details in the report titled “202207727 Michigan Data Collection – Final”.

(C) Seven lead sheathed cables in the Detroit River. DR 1. July 2022, Trenton, MI.

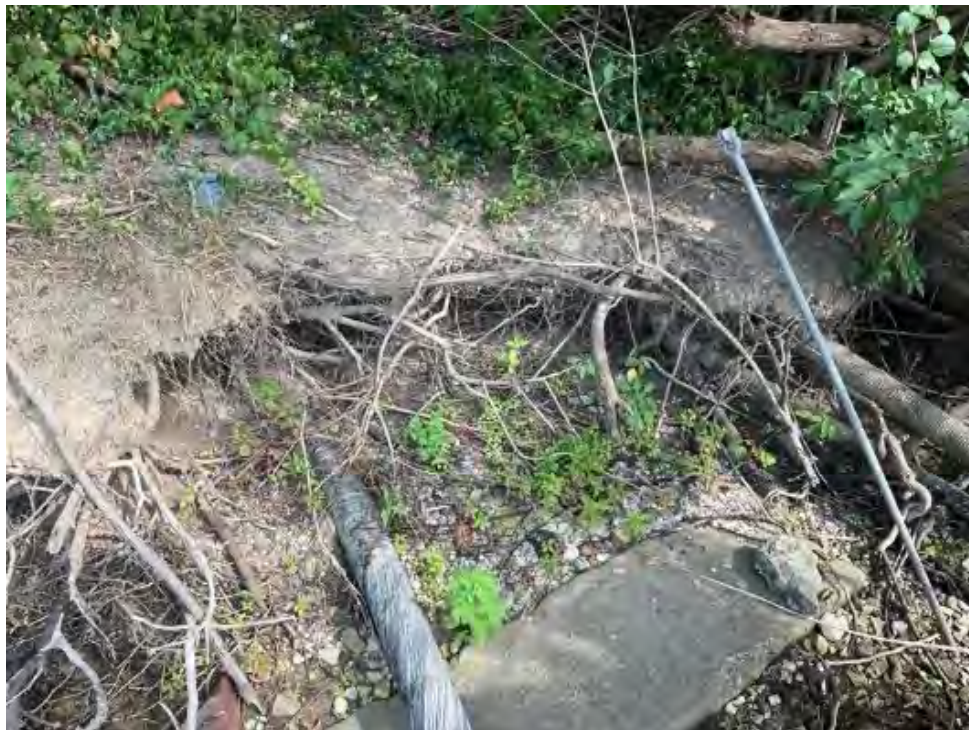
(D) Lead sheathed cables from (C) continuing past the tree line. They are buried in the ground and run up the hill to a Bell Systems manhole. DR 1. July 2022, Trenton, MI.

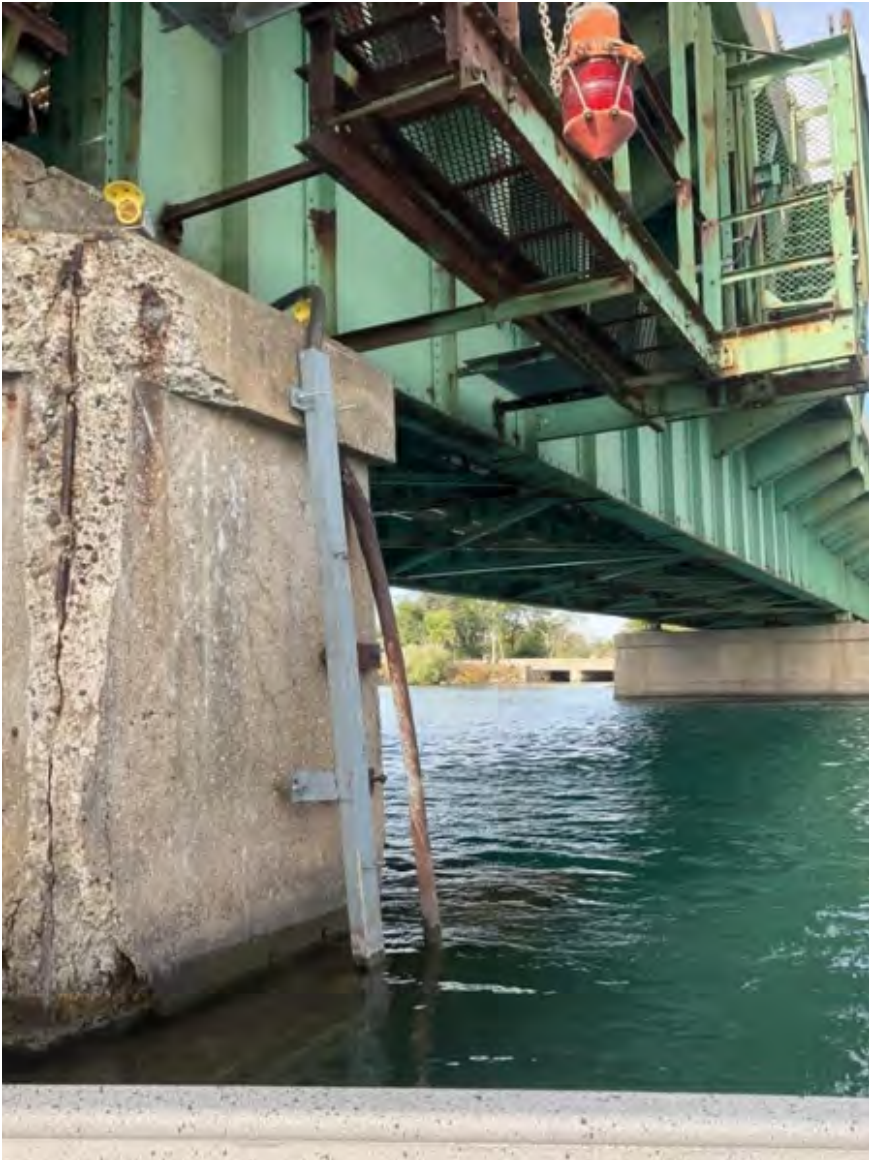
(E) Lead sheathed cable along the Grosse Ile Parkway Bridge. The cable runs through the concrete and is cut just above the ledge. DR 2. Grosse Ile Township, MI

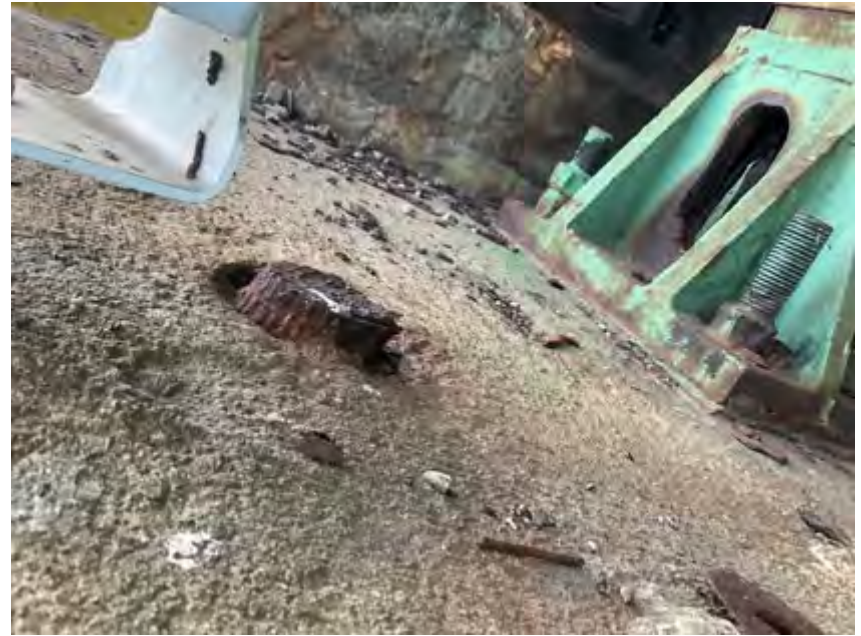
(F) Cut lead sheathed cable, referenced in (E). DR 2. Grosse Ile Township, MI.

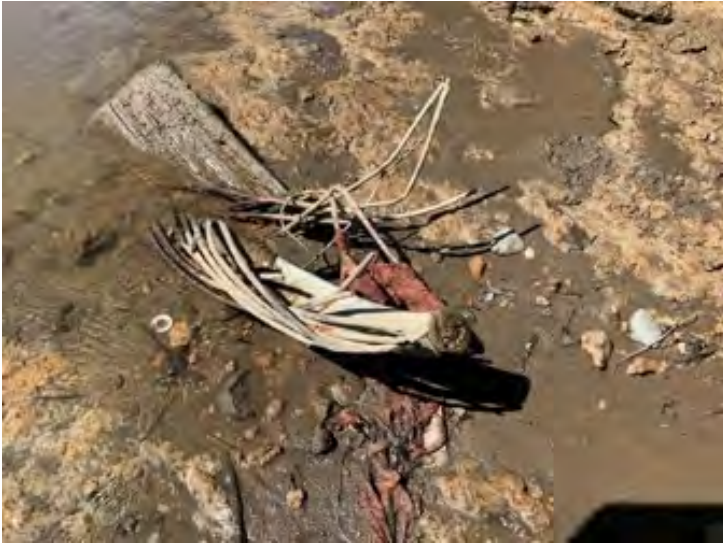
(A) Abandoned lead sheathed cable near Ross Island. WR 1. August 2022, Portland, Oregon.

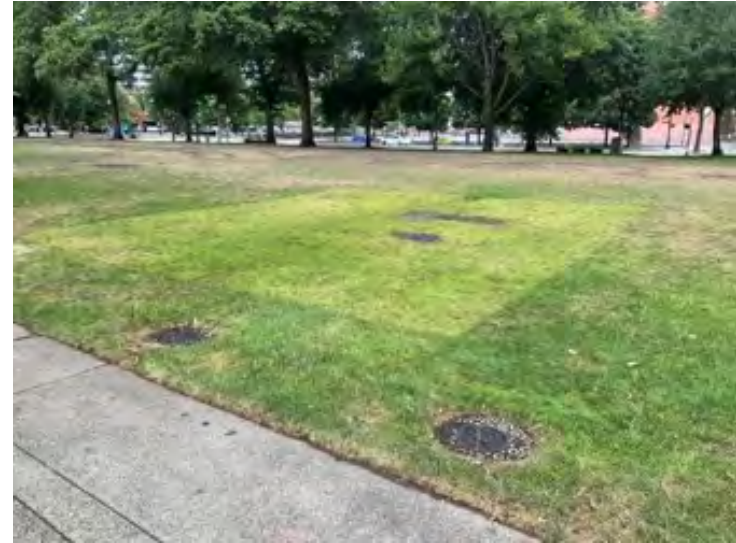
(C) Five Bell Systems manholes with vault. WR 2.2. August 2022, Portland, Oregon.

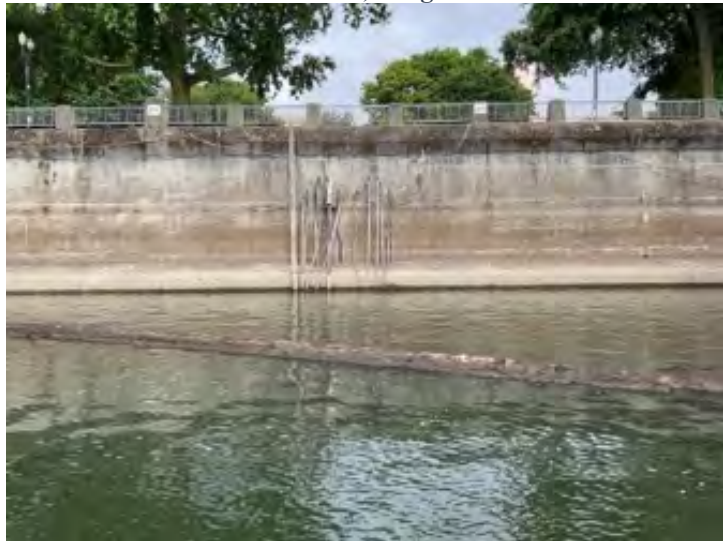
(B) Eleven cables near Maritime Museum and Waterfront Park. WR 2.2. August 2022, Portland, Oregon.

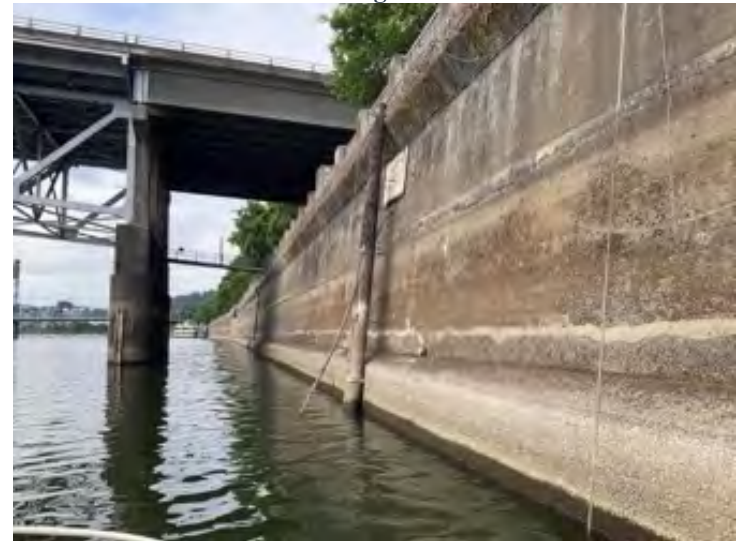
(D) Smaller lead sheathed cable below Western Union Telecom Co. Sign. WR 3. August 2022, Portland, Oregon.

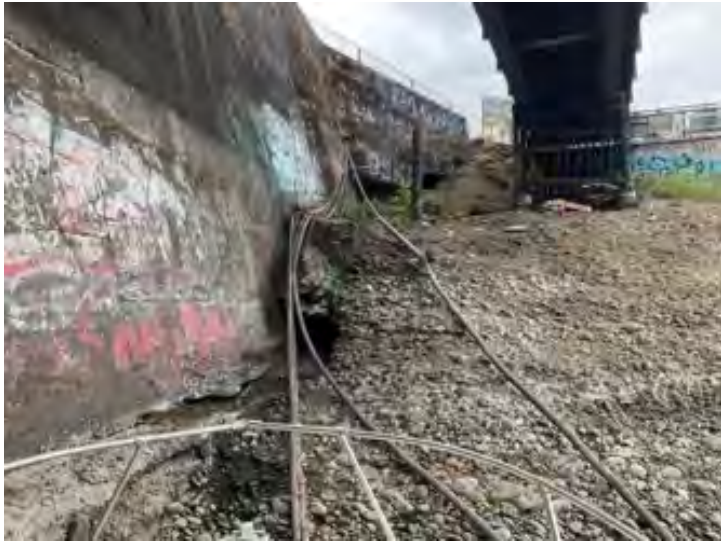
(E) North Steel Bridge cables. WR 6. August 2022, Portland, Oregon.

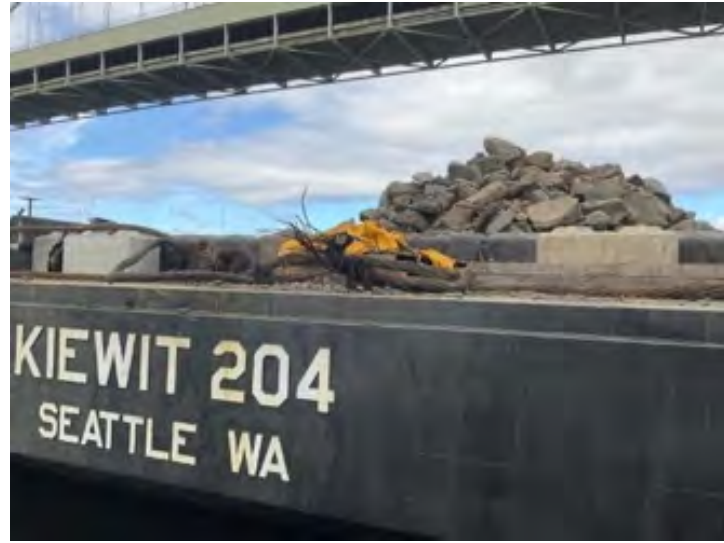
(G) Active construction site. Lead sheathed cable. Kiewit 204. WR 8. August 2022, Portland, Oregon.

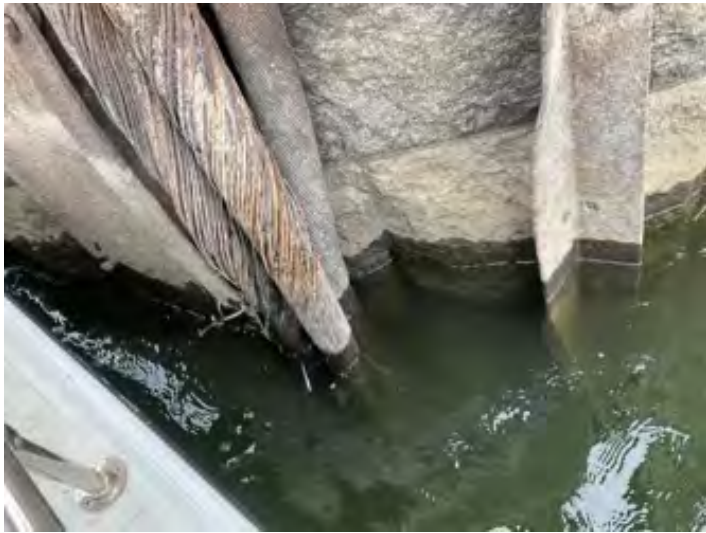
(F) NW Broadway Bridge cables. WR 7. August 2022, Portland, Oregon.

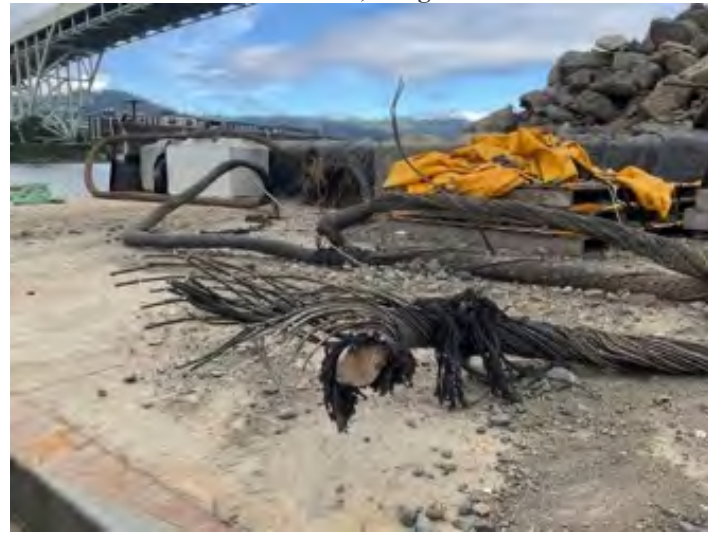
(H) Possible Abernathy Bridge cable. WR 8. August 2022, Portland, Oregon.

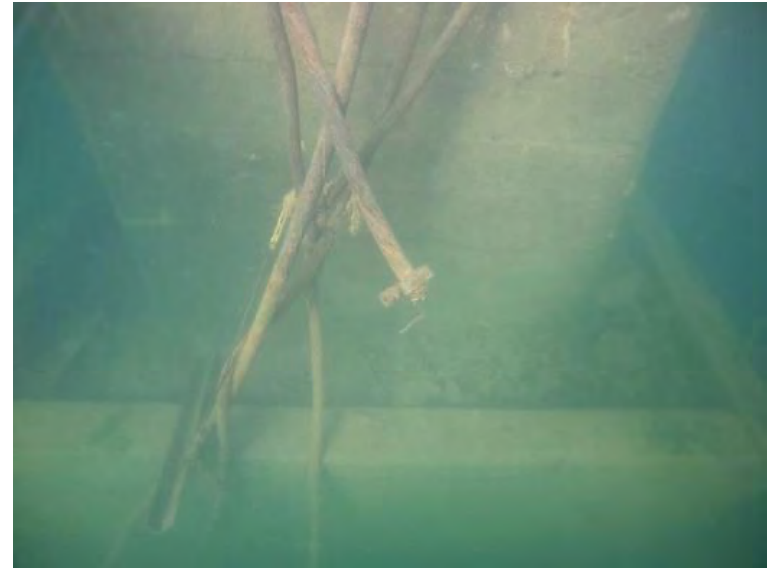
(B) Photo. Lead sheathed cables just below the surface. Site LP 4.1. August 2022, Lake Pend Oreille, ID.

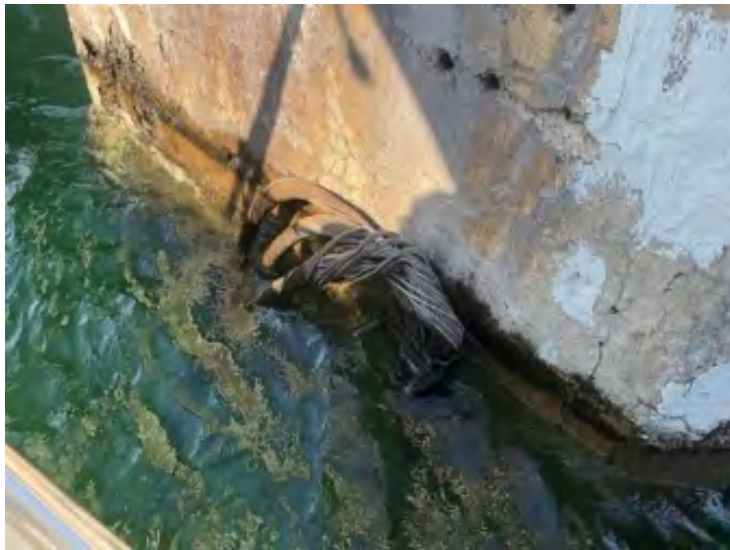
There was one point with visible lead sheathed cables in Idaho that was found in Lake Pend Oreille on the southeast end of the railroad bridge near Highway 95. This collection of cables was cut and left in place at the base of the bridge. At the time of our most recent visit, there was construction work and a large barge over the location of the cables which are tangled underwater. Refer to Figure 15A-D and Figure 16E-G for Lake Pend Oreille photos.

(C) Lead sheathed cables cut and hanging from bridge. Site LP 4.1. August 2022, Lake Pend Oreille, ID.

Overall, our findings in Idaho showed few visible lead sheathed cables with a high potential of buried cables in areas where signs and Bell Systems manholes were observed. The cables found off the old railroad bridge have been cut and left near the base of the bridge. They are clearly abandoned and should be removed. Further investigation into the status of these cables and how to move forward with the next steps of removing the remnants is suggested.

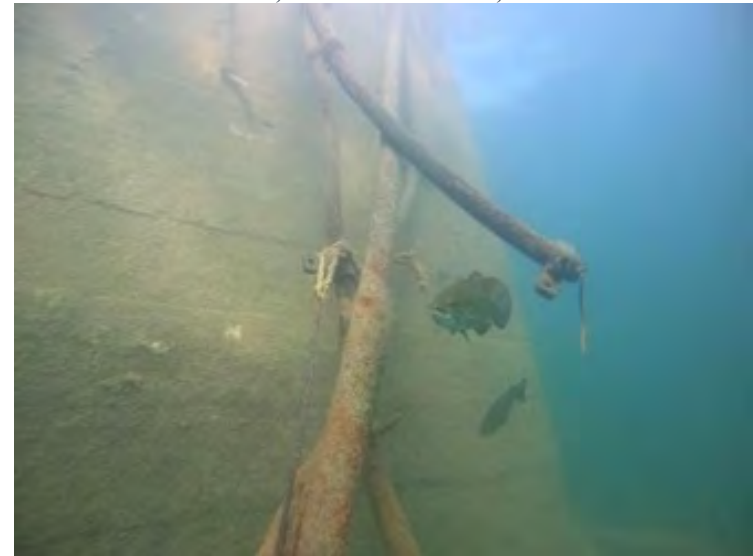
(D) Bare lead (upper-left). Cut end, near fish (mid-right). Site LP 4.1. August 2022, Lake Pend Oreille, ID.

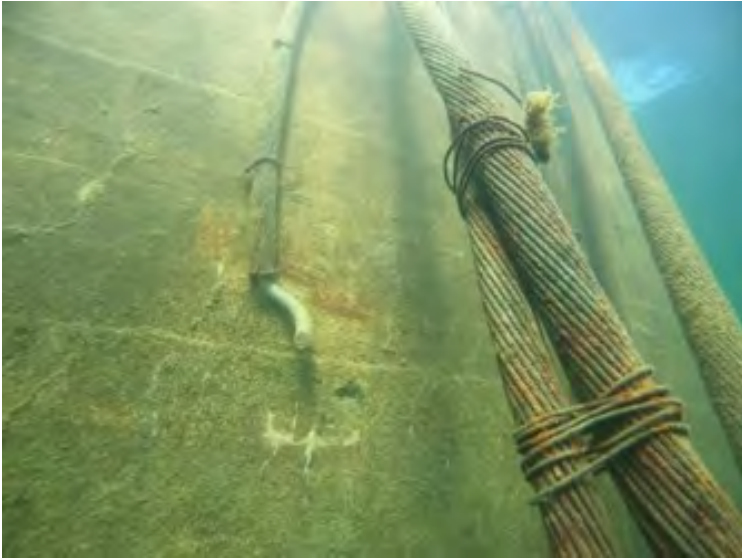
(E) Close up of small, cut, bare lead sheathed cable underwater. Site LP 4.1. August 2022, Lake Pend Oreille, ID.

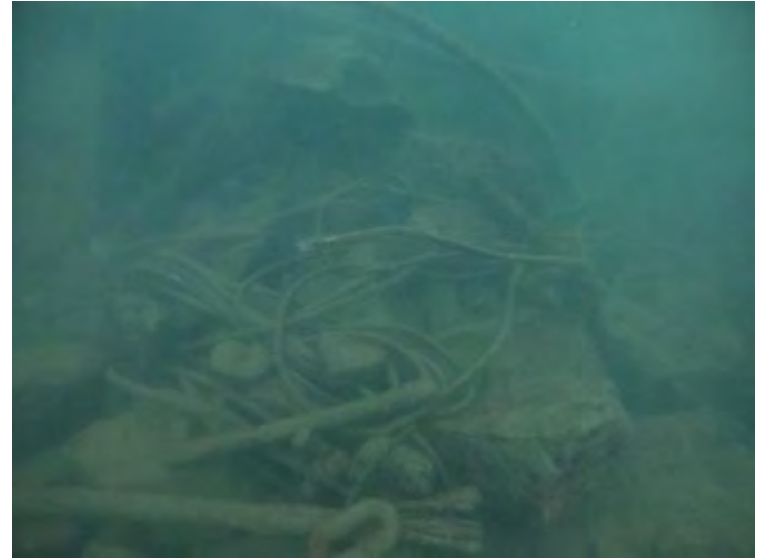
(F) Lead sheathed cables abandoned and coiled below the surface. Site LP 4.1. August 2022, Lake Pend Oreille, ID.

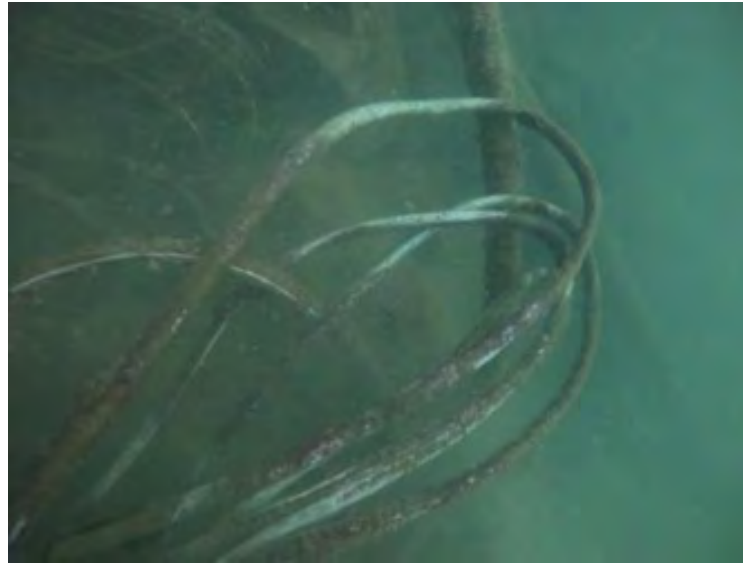
(G) Close up of bare lead from abandoned cables. Site LP 4.1. August 2022, Lake Pend Oreille, ID.

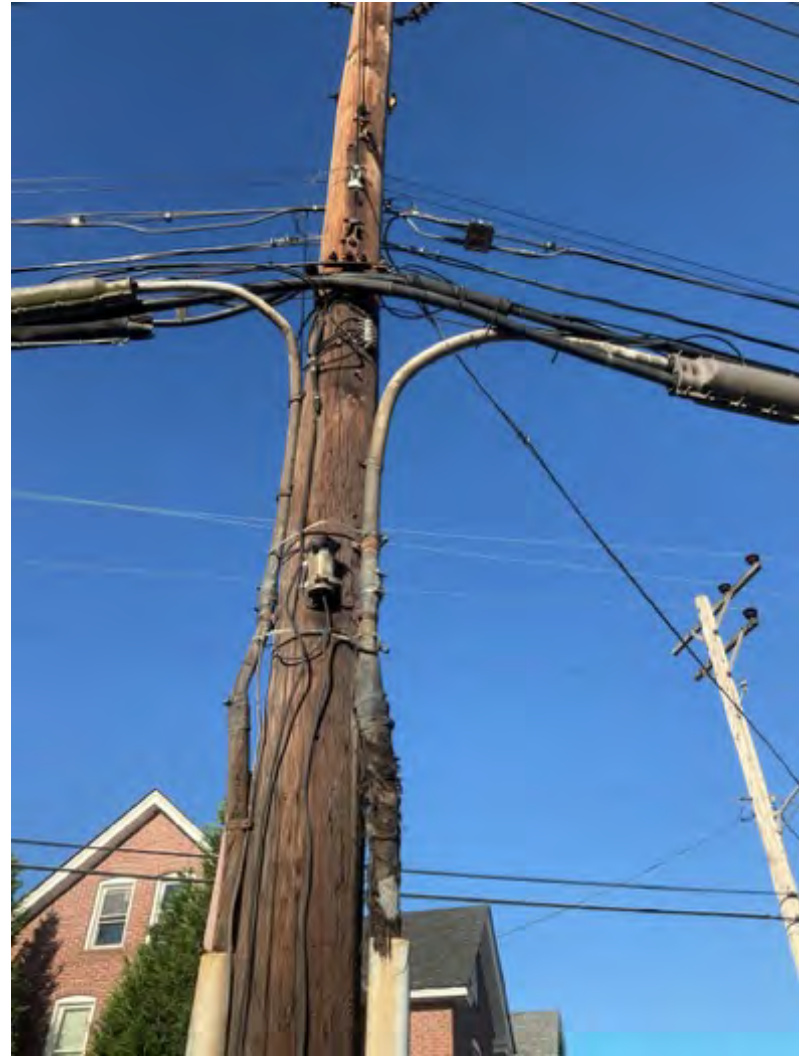
(C) Close up of lead sheathed cable and splice boxes referenced in (A). October 2022. Natrona, Pennsylvania.

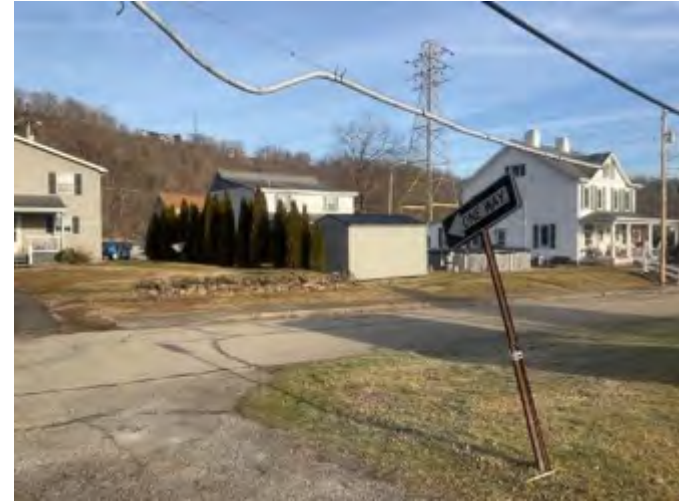
(F) CT11. Overhead lead sheathed cable running through a residential area near the end of town. February 2023. Coal Center, Pennsylvania.
