Lead Cable Investigation

June 30, 2023

Tom Neltner
Environmental Defense Fund
1875 Connecticut Ave NW
Washington, D.C. 20009

Marine Taxonomic Services, Ltd.
Below the Blue 501(c)3

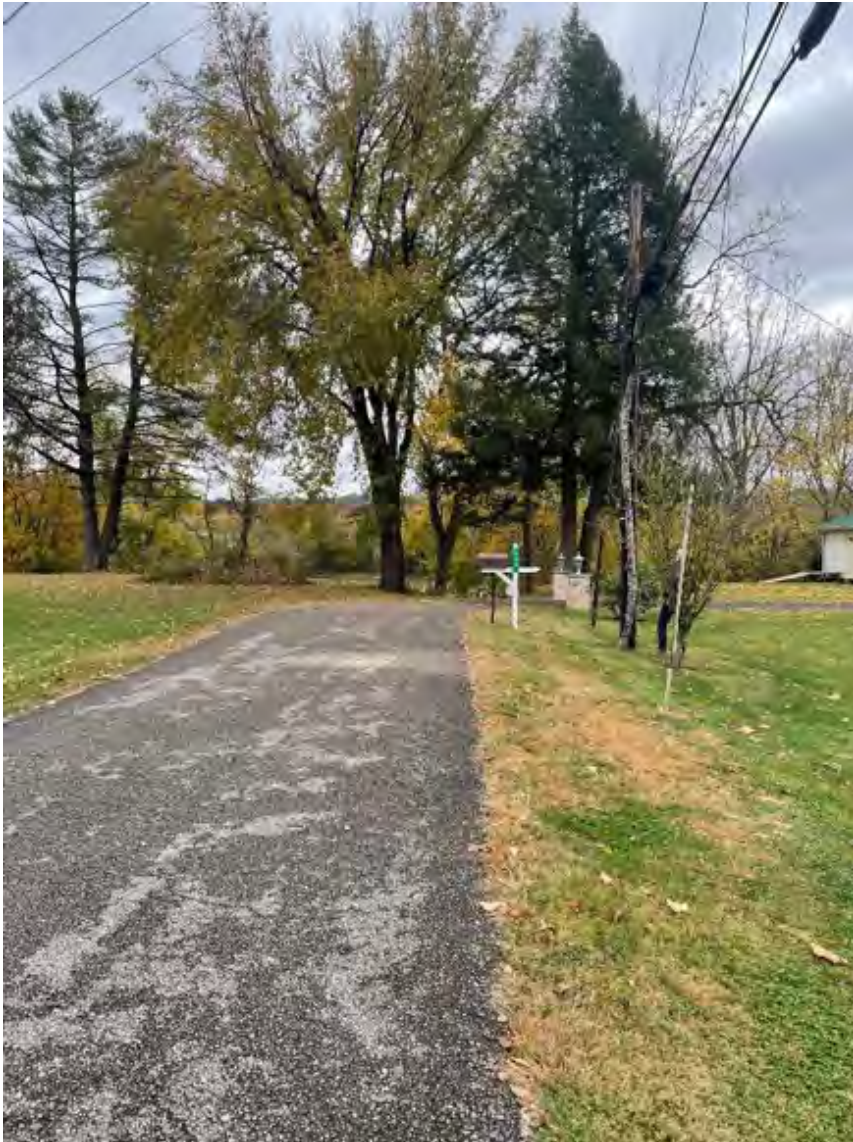
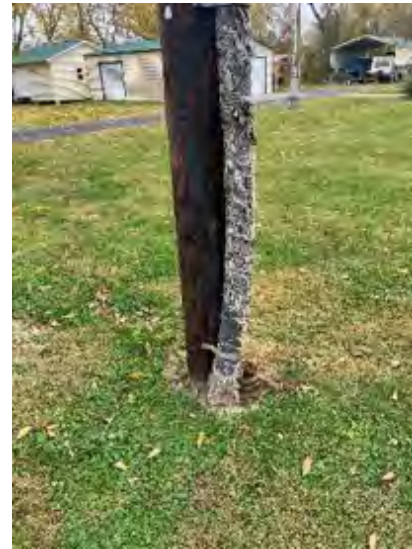
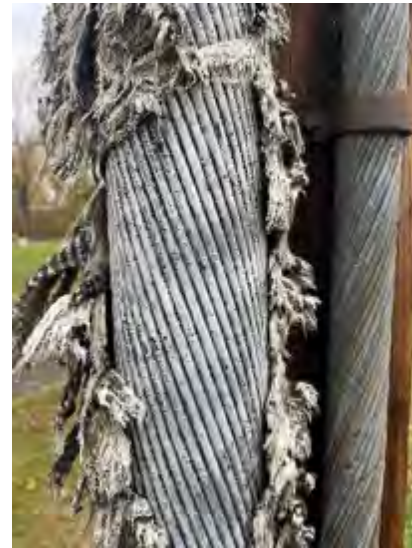
Figure 19. Photos taken in West Virginia. Site for the Old Pliny Ferry Crossing at Frasier's Bottom. Two bare lead sheathed cables were observed at the end of Ferry Lane. KR 1.3. October 2022, Pliny, West Virginia.

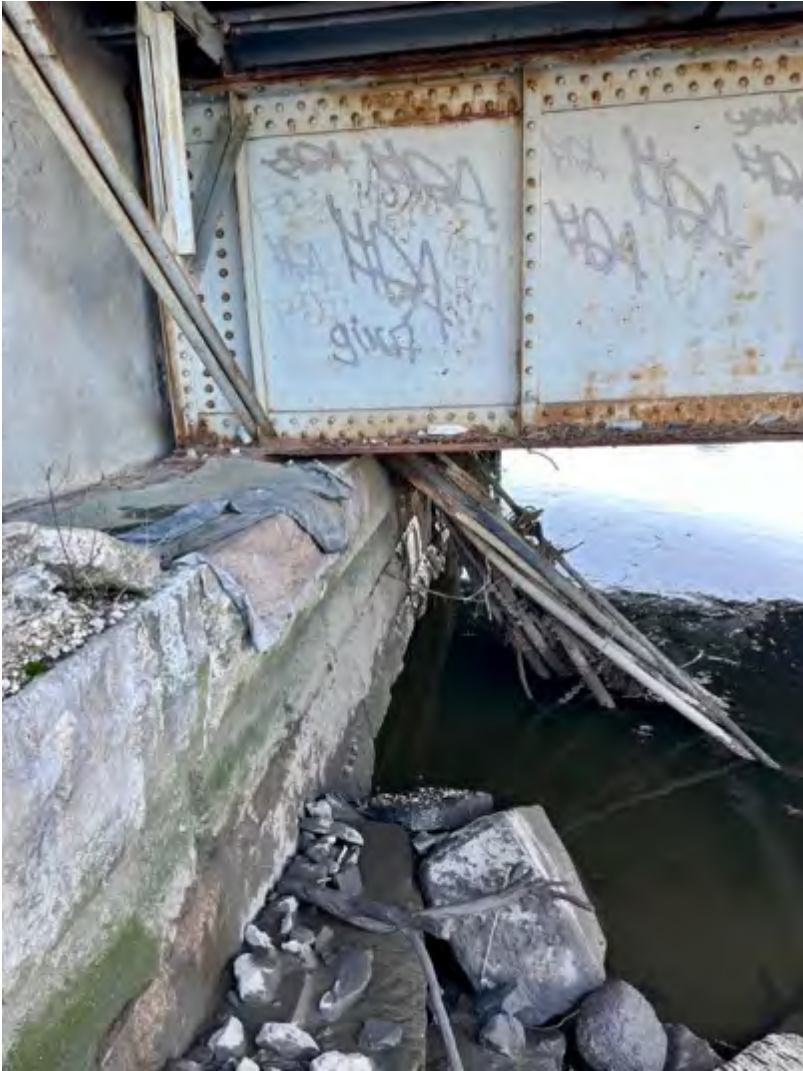
(H) Evidence of homeless sleeping next to these cables along the Passaic River. Passaic 2. January 2023, Harrison/University Heights, New Jersey.

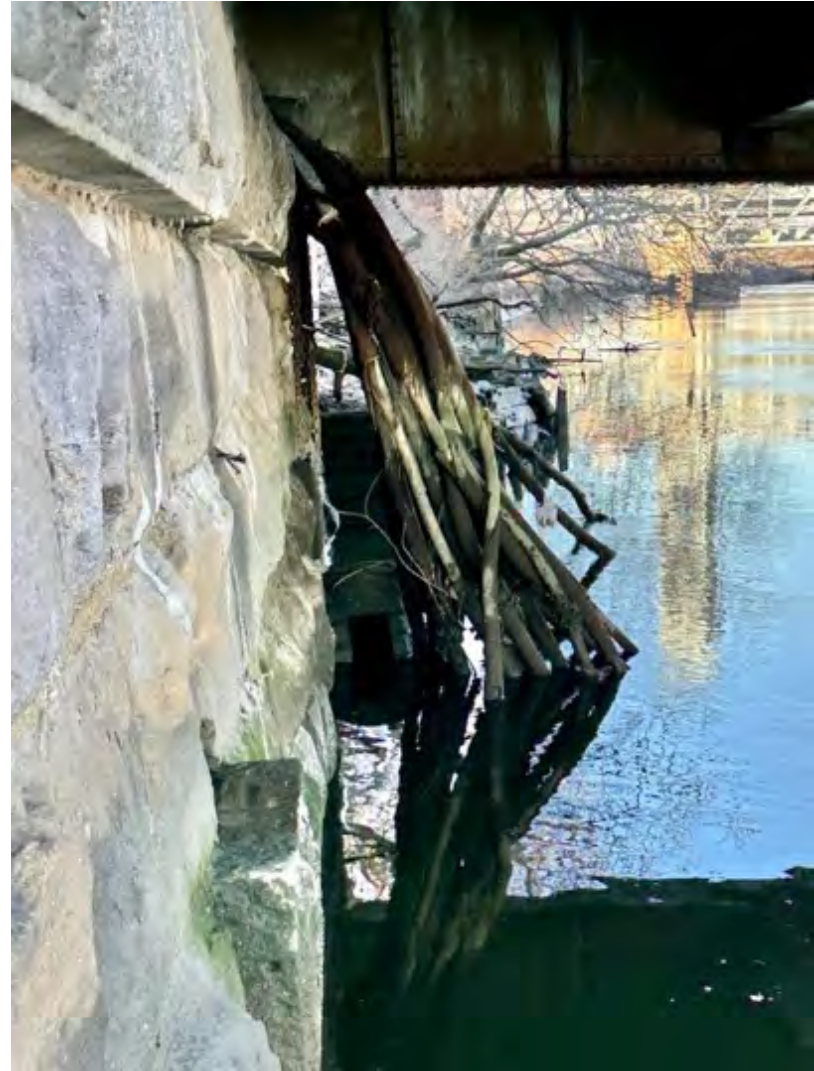
(I) Cable location with twenty lead sheathed cables underneath the Bridge Street Bridge (Harrison Ave.). Passaic 2.1 January 2023. Harrison/University Heights, New Jersey.

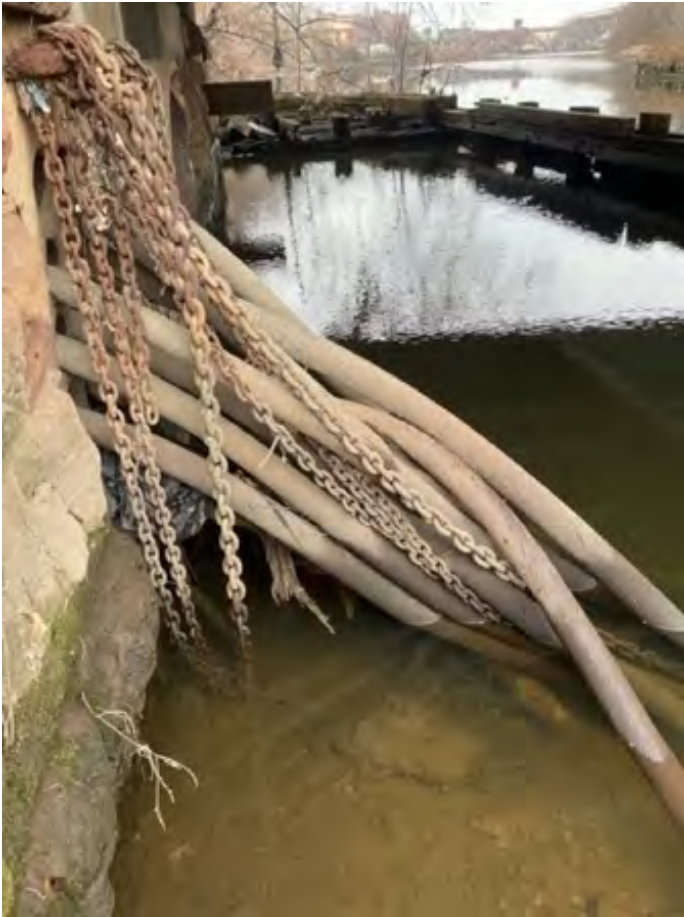
(J) Part of a complex site containing twenty-one cables near Washington Crossing State Park along the Passaic River. Passaic 5.10. January 2023. New Jersey.

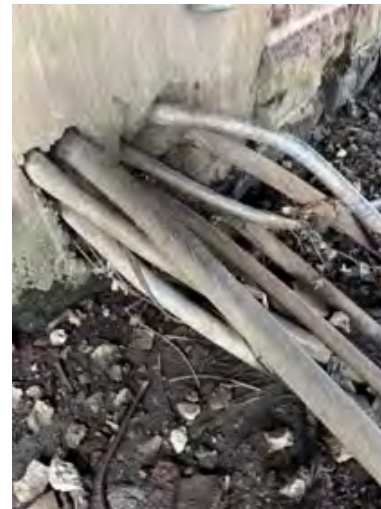
(L) Part of an eleven-cable location found near Wall Street Bridge, between Garfield and Wallington. Passaic 8. January 2023. New Jersey.

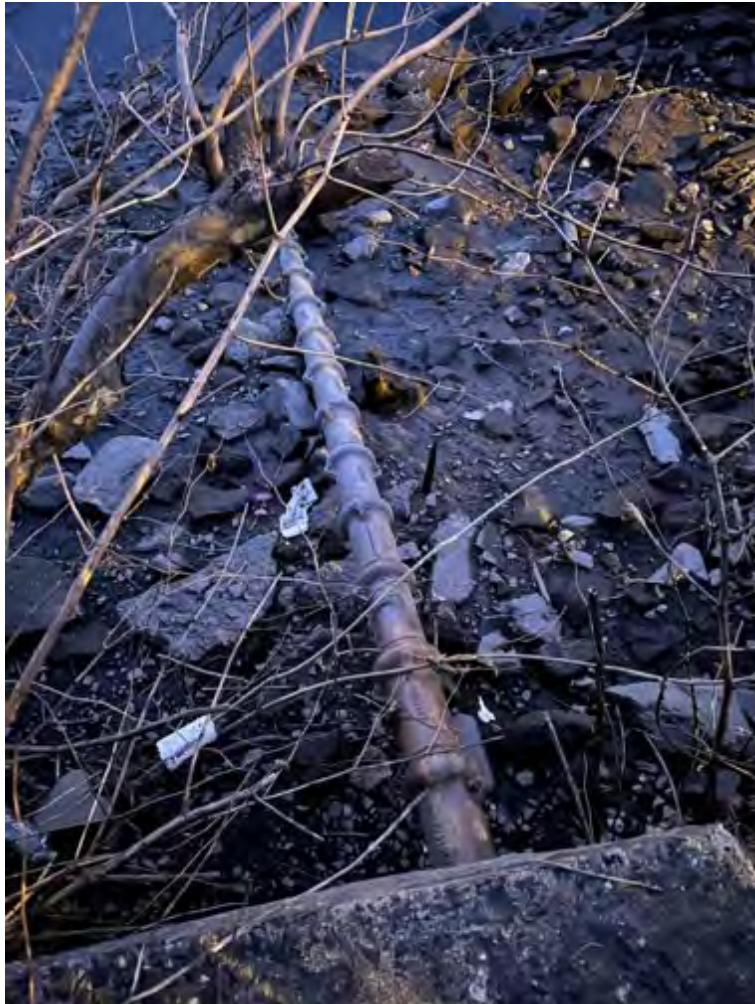
(A) Armored cable approximately fifteen feet from the water's edge. Passaic 3. January 2023, Belleville, New Jersey.

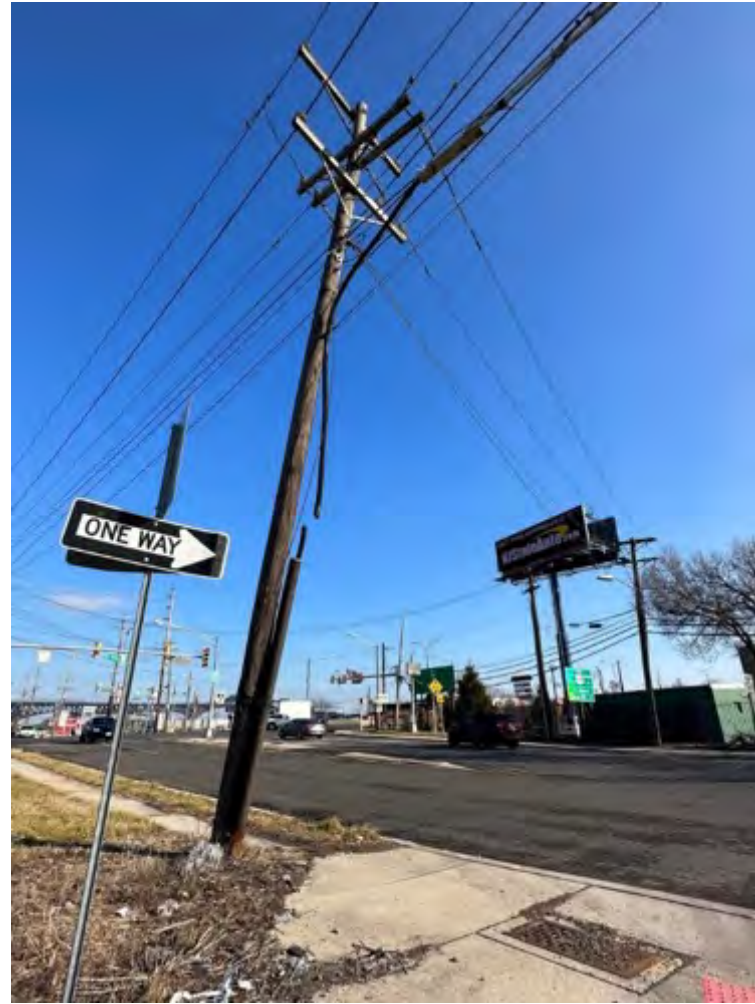
(B) Overhead cut, lead sheathed cables in the South Kearny area. There are two cables that run approximately 0.4 miles. South Kearny End A. January 2023, Kearny, New Jersey.

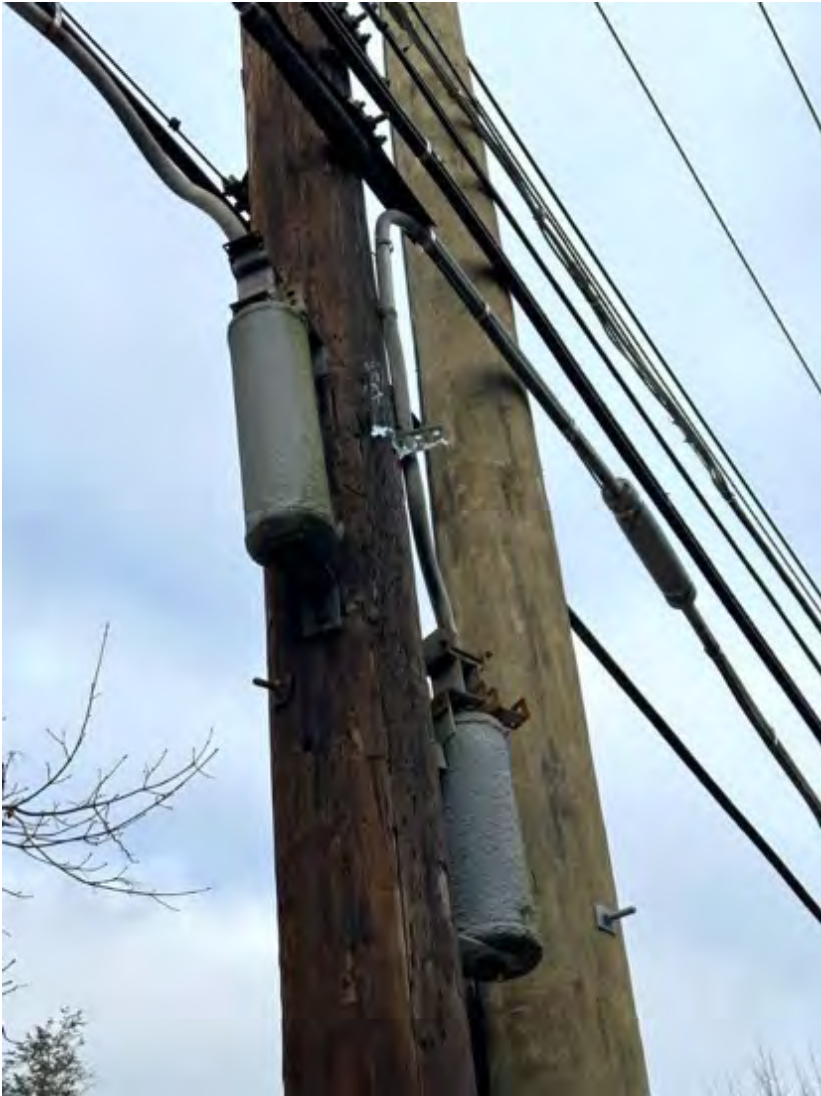
(A) Close up of telephone poles with overhead lead sheathed cable and leaded splice boxes. January 2023. Highland Falls, New York.

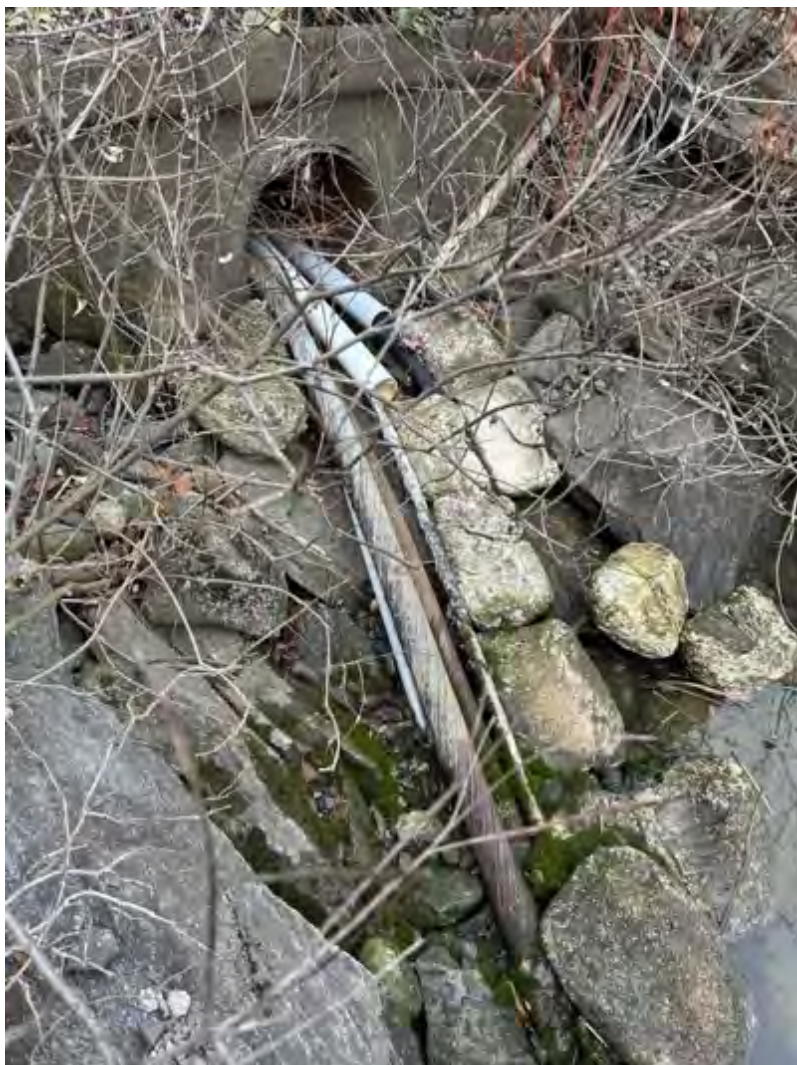
(D) Cables run under the road and into the Hudson River near the Mid-Hudson Bridge at Point of Interest: Hudson 3.1. January 2023. Highland, New York.

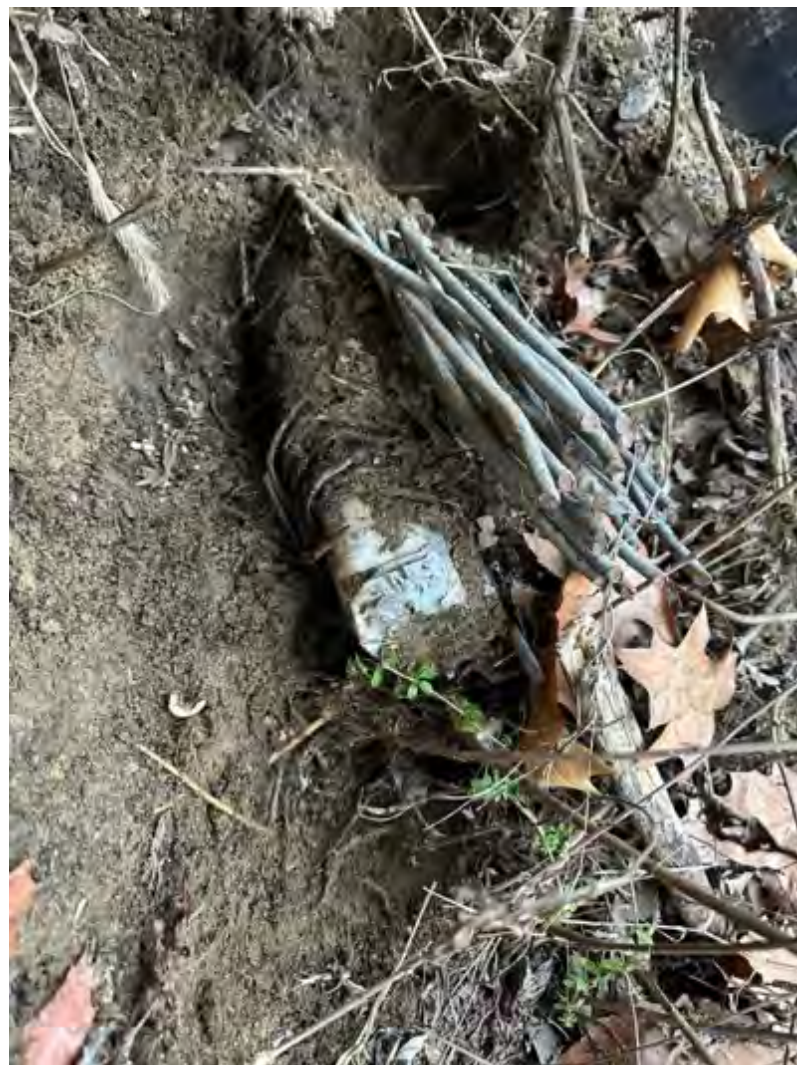
(E) Severed cable and steel wire at the base of an old telephone pole, across from those shown in (D). Point if Interest: Hudson 3.4. January 2023. Highland, New York.

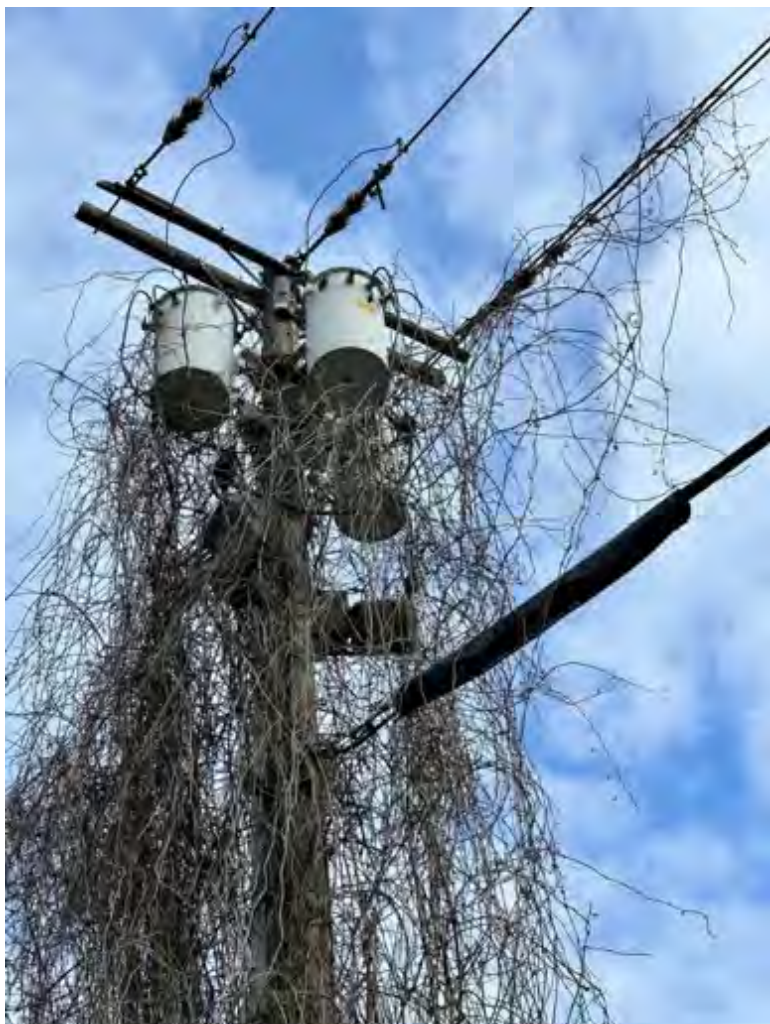
(F) “Squirrel Guard” tied around an exposed area of lead sheathed cable. Point of Interest: Newburgh 1. January 2023, Newbury, New York.

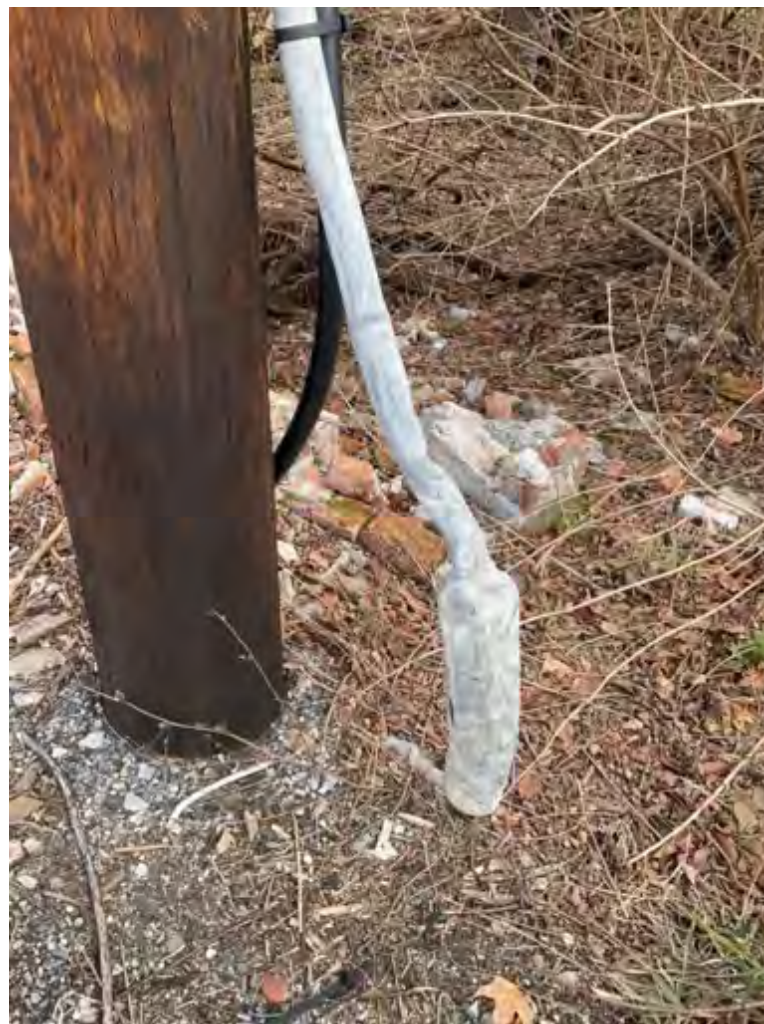
(G) Damaged lead cable and splice box at the base of an old telephone pole. Point of Interest: New Windsor 1. January 2023, New Windsor, New York.

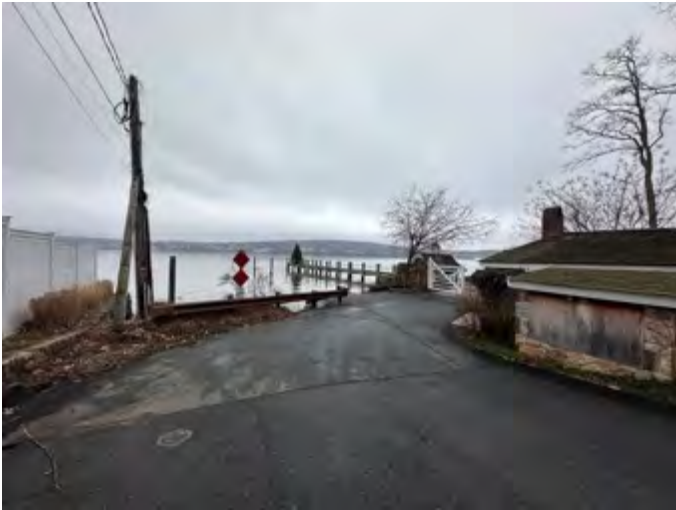
(H) Abandoned 5" lead sheathed cable along the Hudson River. January 2023, Palisades, New York.

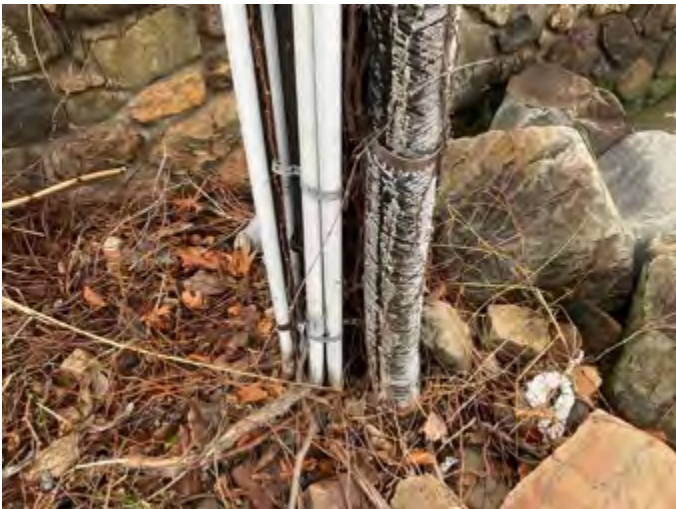
(I) Close up of abandoned 5" lead sheathed cable along the Hudson River. January 2023, Palisades, New York.

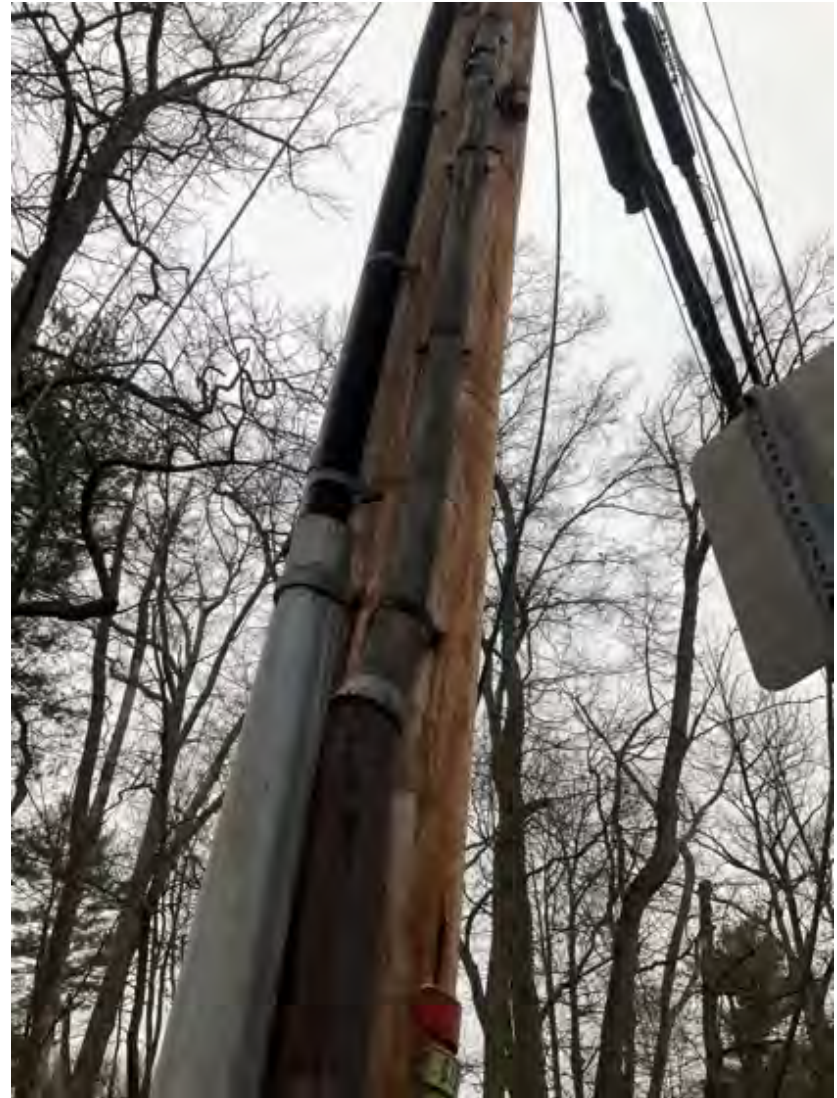
(J) Bare lead sheathed cable running up telephone pole in the Palisades. January 2023, Palisades, New York.

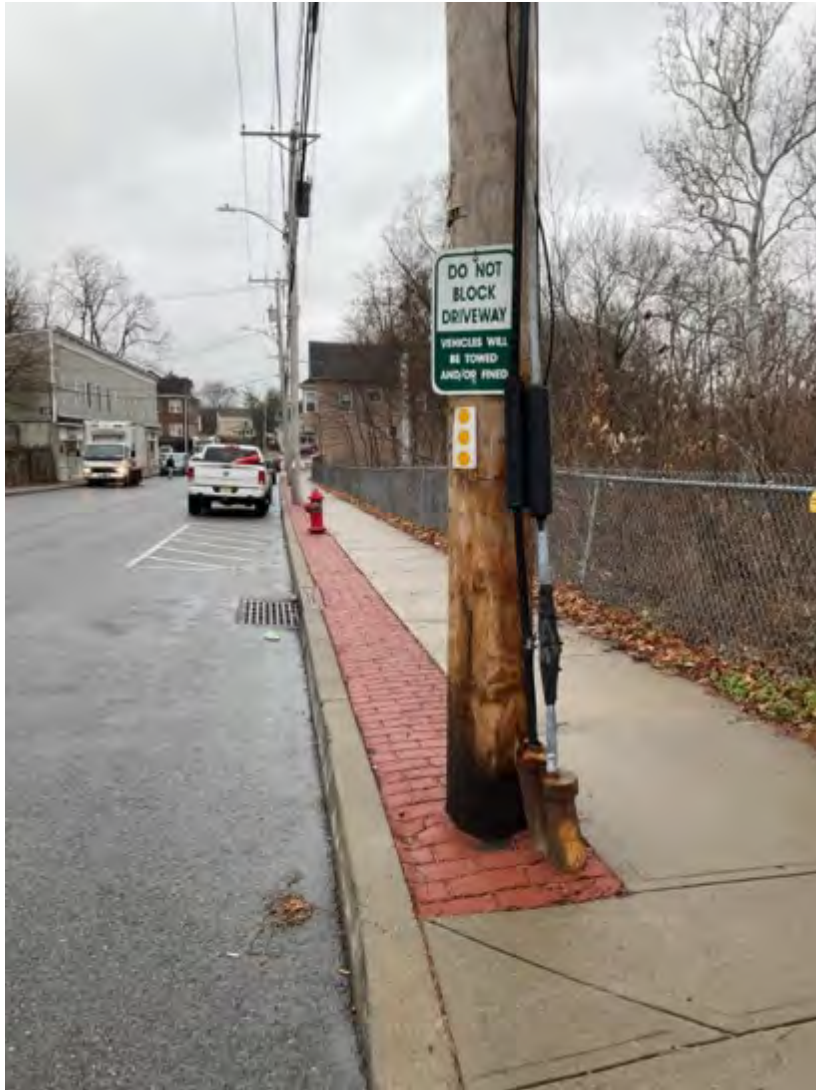
(K) Damaged lead sheathed cable at the base of a telephone in Wappingers Falls. Point of Interest: Wappingers Falls 3. January 2023, Wappingers Falls, New York.

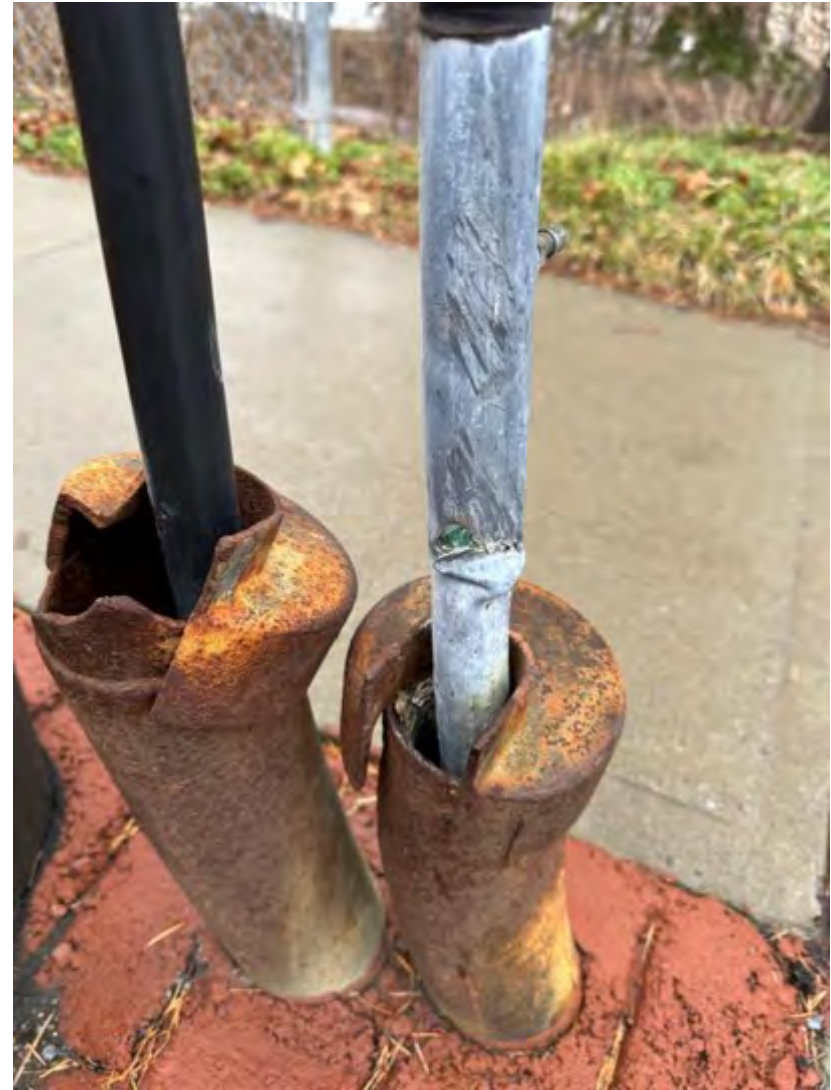
(L) Close up of damaged lead sheathed cable shown in (K). Wappingers Falls 3. January 2023, Wappingers Falls, New York.

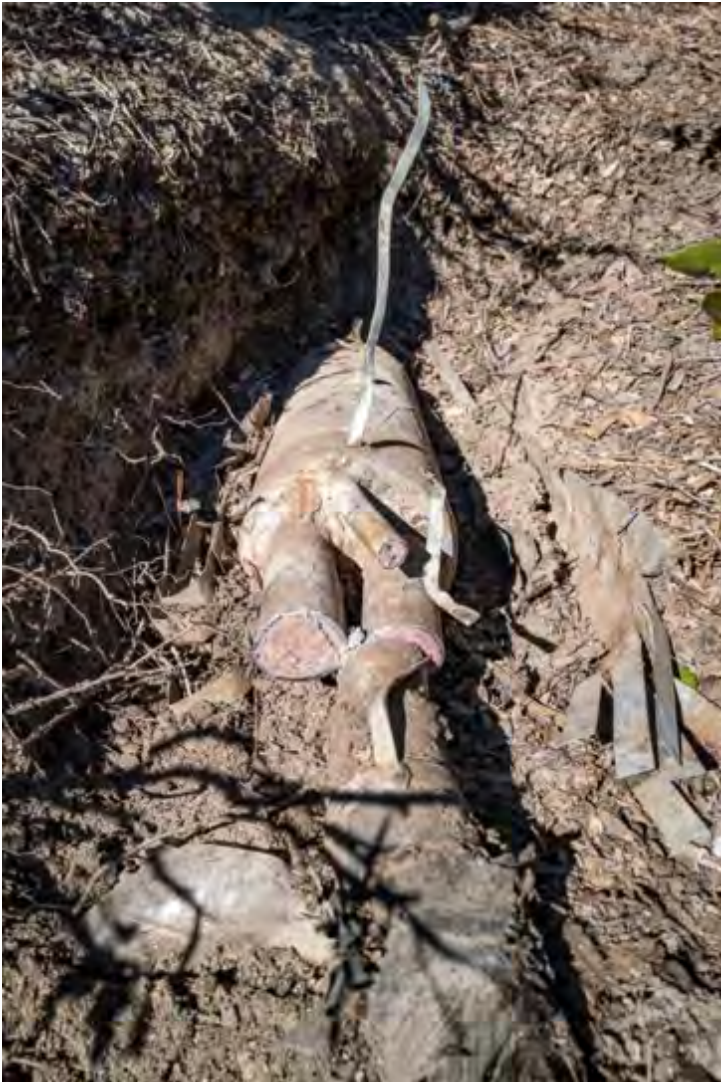
(A) Severed lead sheathed cables, and lead splice box on land. This photo was during a site visit with AT&T in January 2021.

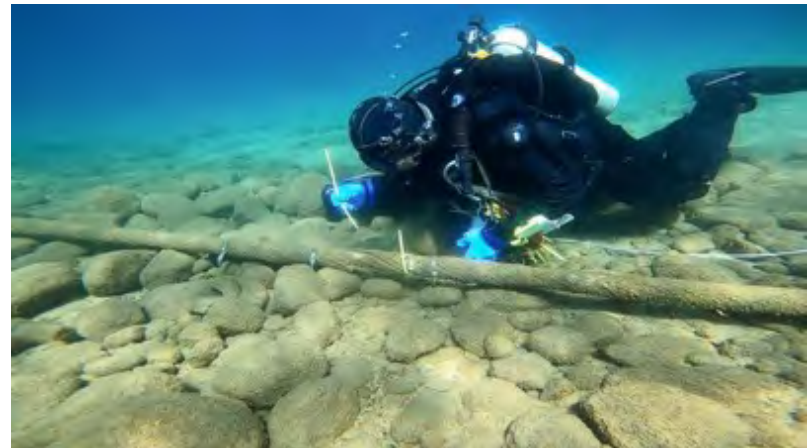
(C) Diver marking locations of damage during a survey in April/March 2022, Lake Tahoe, California.

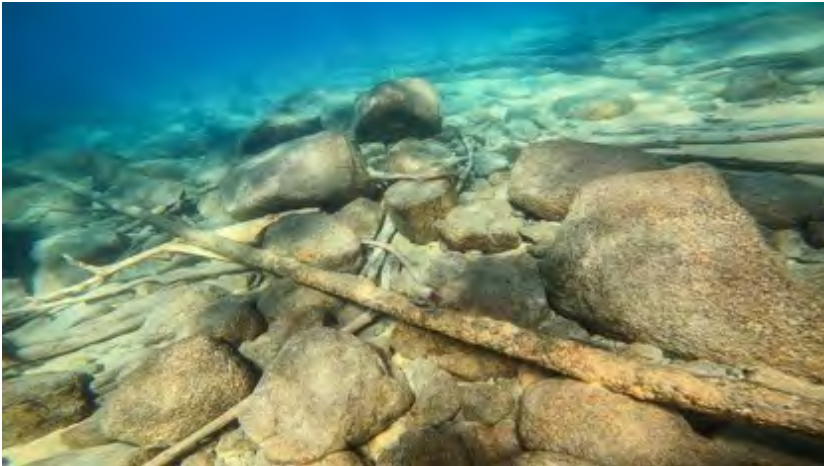
(D) Lead sheathed cable laying among boulders on the lake bottom. April/March 2022. Lake Tahoe, California.

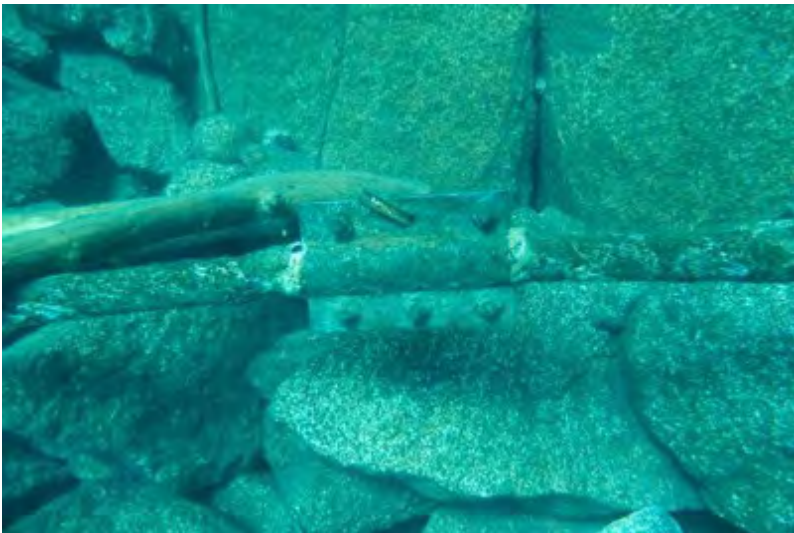
(E) Part of a broken anchor on the cable near Rubicon. April/March 2022. Lake Tahoe, California.

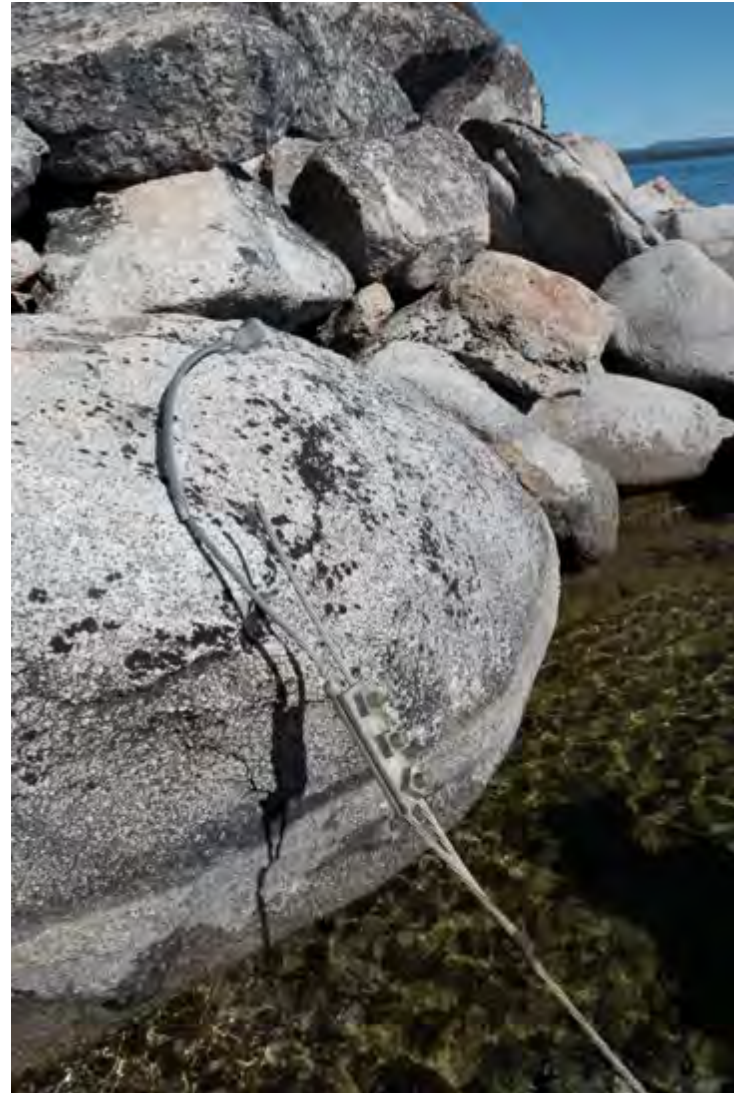
(F) Broken cable anchor on land near Rubicon. April/March 2022. Lake Tahoe, California.

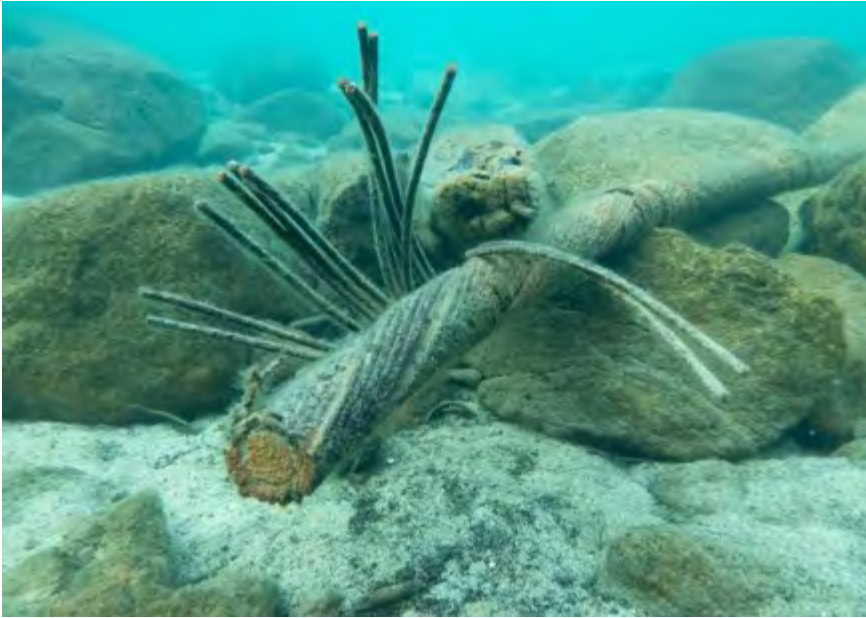
(G) Severed end of 1920's cable in Emerald Bay. May 2021, Emerald Bay - Lake Tahoe, California.

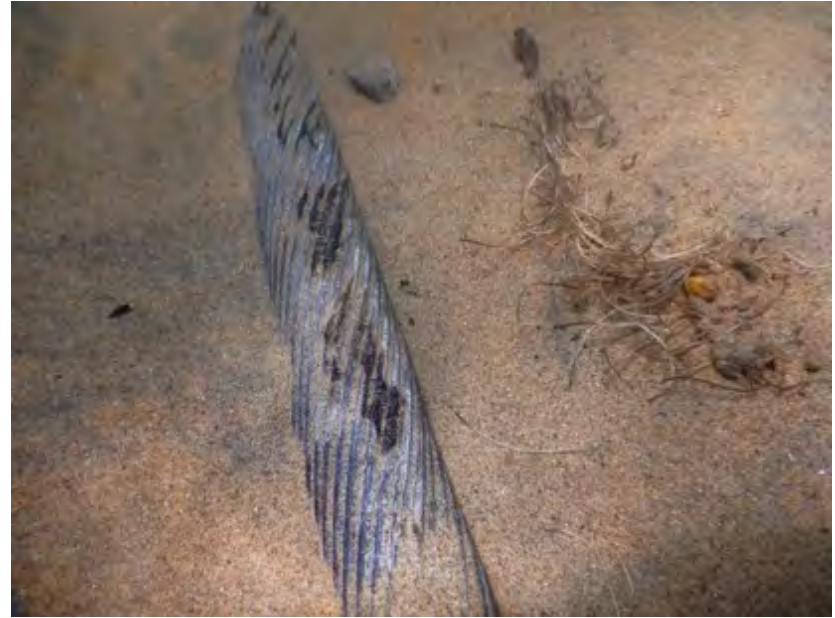
(H) 1920's lead sheathed cable resting on the lake bottom in Emerald Bay. May 2021, Emerald Bay - Lake Tahoe, California.
