Forgotten Reach of the Rio Grande, Fort Quitman To Presidio, Texas

Section 729
January 2008

Prepared by:
US Army Corps of Engineers
Albuquerque District

TEXAS COMMISSION ON ENVIRONMENTAL QUALITY

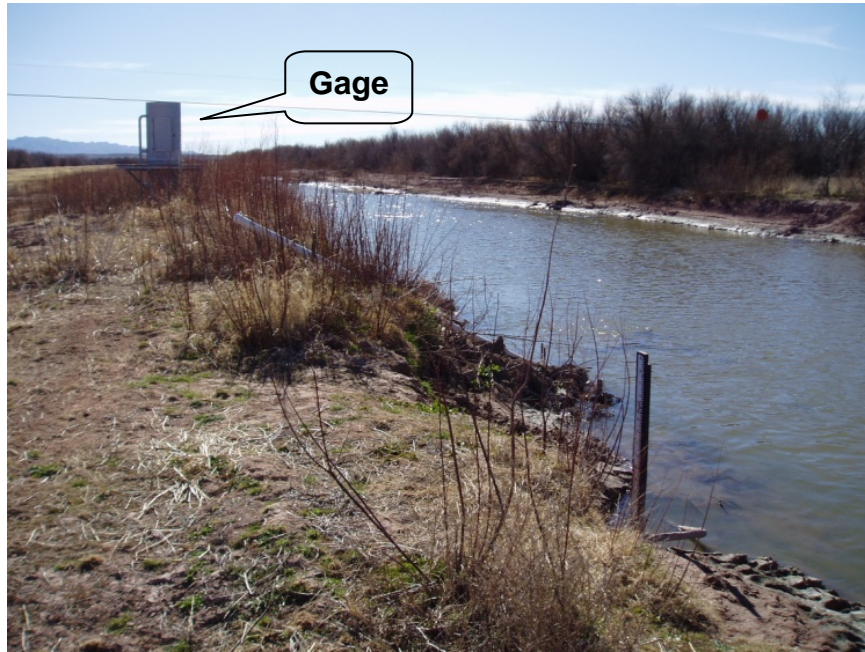
Figure 2 - Fort Quitman IBWC gage in the rectified channel at the upper end of the Forgotten Reach looking downstream.

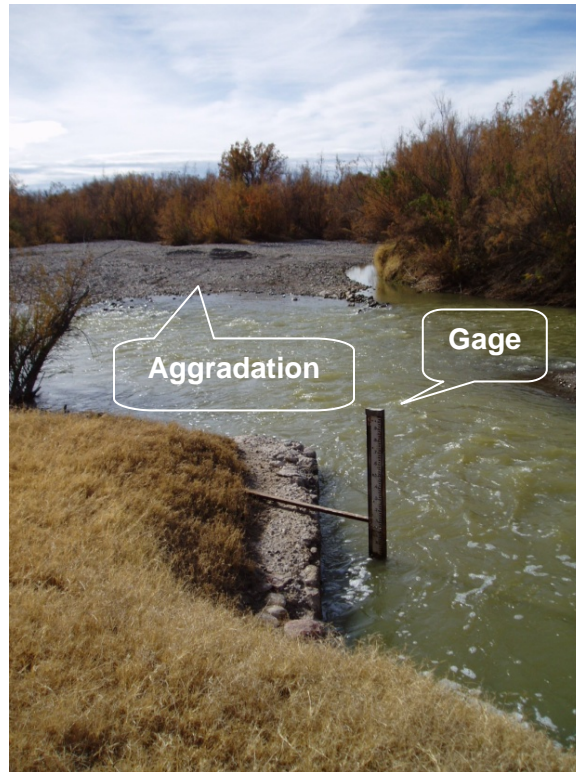
Figure 3 - Candelaria IBWC Gage upstream of Capote Creek and Candelaria, Texas, January 2007. Note aggradation from influence of San Antonio Diversion Dam (Mexican) just downstream and San Antonio arroyo confluence just upstream.

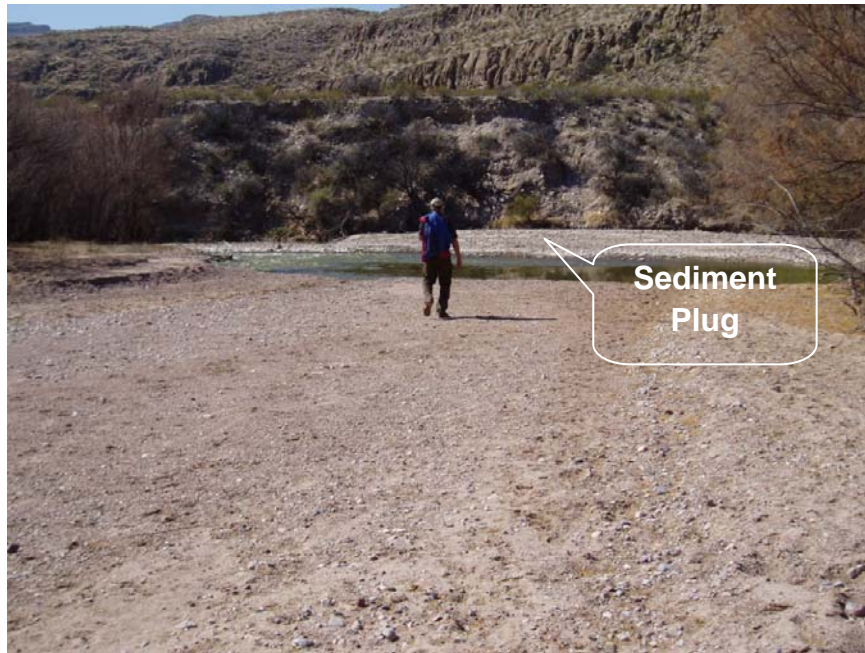
Figure 4 - Confluence of the Green River with the Rio Grande (42 river miles downstream of Indian Hot Springs, Texas). Note the sediment plug. Photo February 2007.

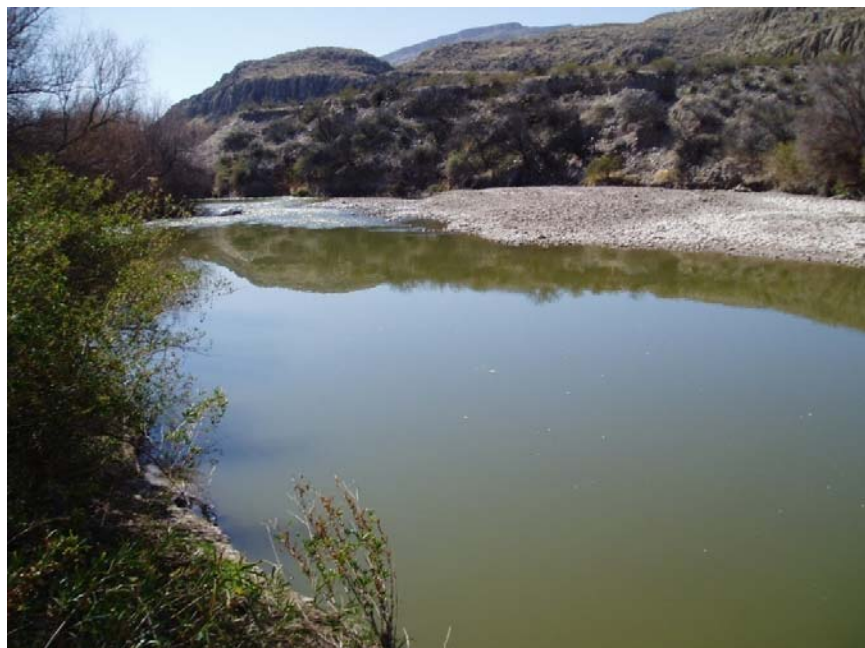
Figure 5 - Upstream view of the Rio Grande and Green River confluence showing relative elevation of sediment plug and abrupt change in gradient of the Rio Grande; looking upstream. Photo February 2007.

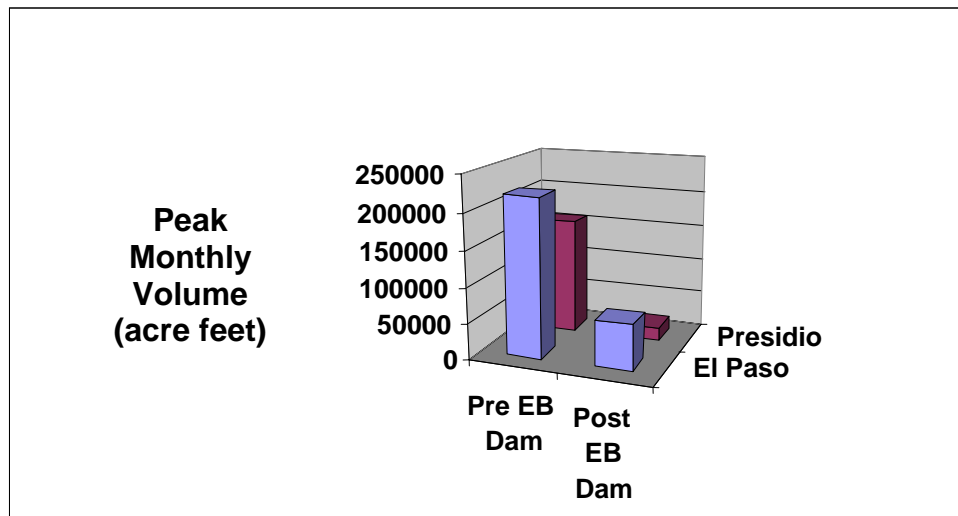
Figure 6 - Average Peak Monthly Volumes at El Paso and Presidio (Pre- and Post-Elephant Butte Construction).

The timing of peak flow months has shifted by an average of three months later in the season as a result of storing and releasing water for irrigation purposes. Prior to 1915, the average monthly volume of water in El Paso averaged nearly 220,000 acre-feet in the month of May. After the completion of Elephant Butte Dam, the peak month shifted to July, with a maximum average volume of 63,700 acre-feet for the last 60 years. Similarly, the peak flow at Presidio prior to 1915 occurred in July with an average of just under 160,000 acre-feet, and during the last 60-year period, the peak month has been October with an average volume of 17,700 acre feet, a reduction in peak flow of almost 90% (Landis 2001). Thus, the peak period of spring runoff flow has been delayed by three months for the Forgotten River, and markedly diminished in quantity. The figure below depicts these changes in maximum average monthly volume, but not the temporal delay associated with them.

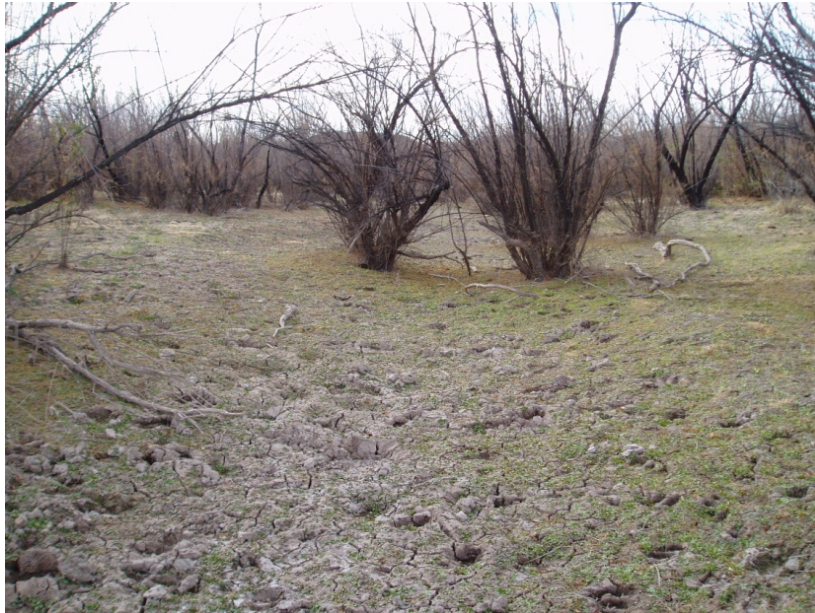
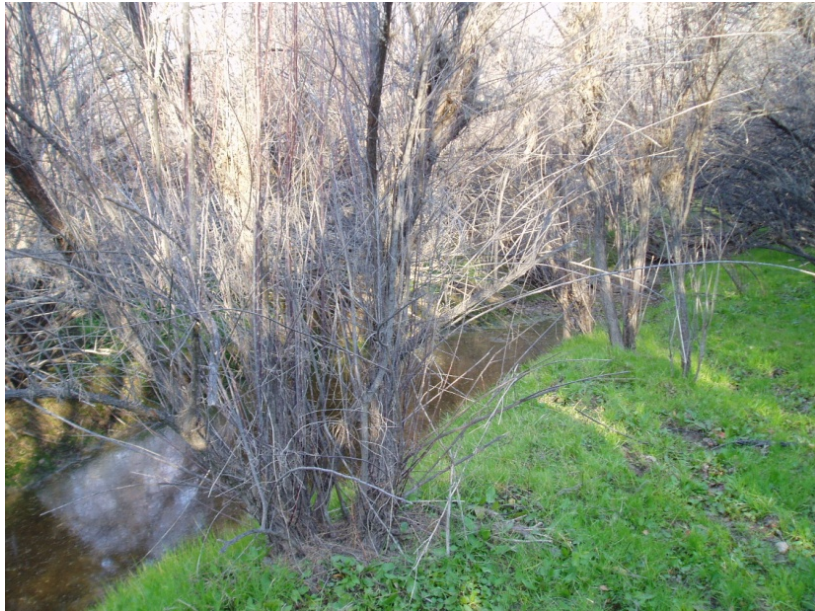
Figure 7 – A narrow, single-thread channel, almost ditch-like in appearance and function, has been vegetatively reinforced by the root system of the saltcedar which line it. This phenomenon is repeated at intervals along the entire Forgotten Reach.

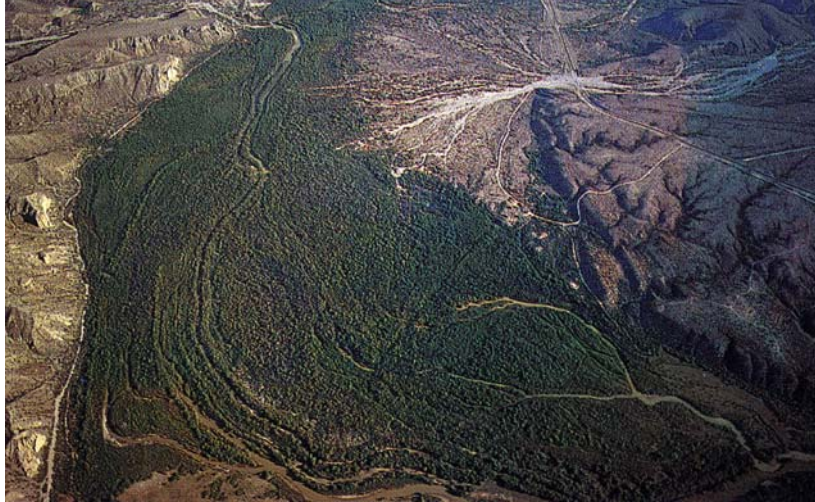
Figure 8 - A myriad of small channels as a result of sediment aggradation and saltcedar establishment characterize much of the Forgotten Reach. Areas like these comprise thousands of acres and are responsible for attenuation of flows. (USGS, 1996)

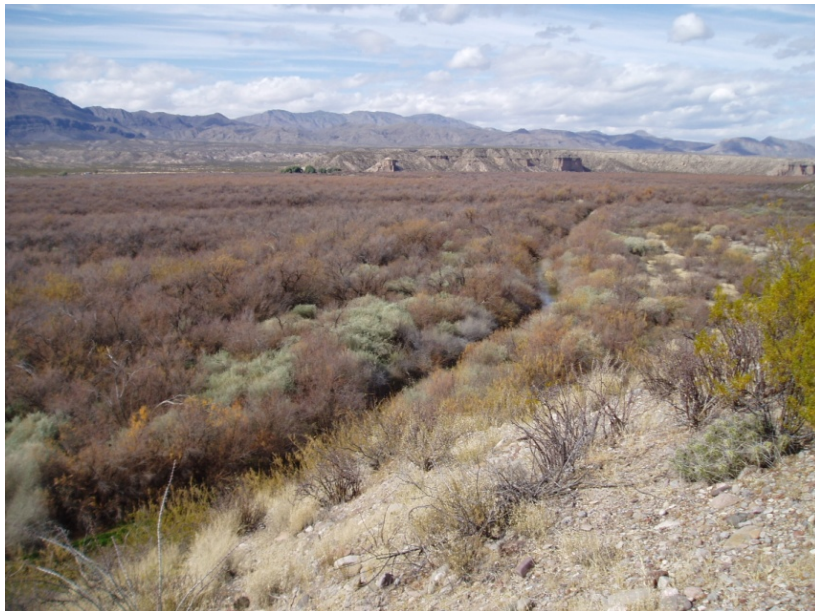
Figure 9 - Below Candelaria, the Forgotten Reach has a narrow, defined channel (foreground) at low flows, but transforms into a myriad of channels through an aggraded floodway at high flows, Photo taken looking upstream January 2007.

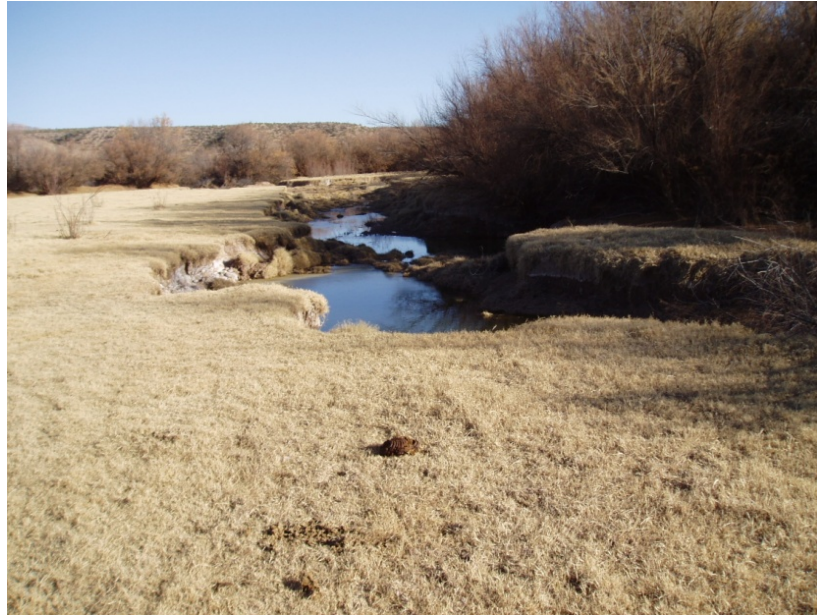
Figure 10 - An avulsion out of a vegetatively reinforced and aggraded channel into an adjacent Bermuda grass pasture upstream of Indian Hot Springs demonstrates the tentative nature of the channel through the Forgotten Reach. Photo taken January 2007.

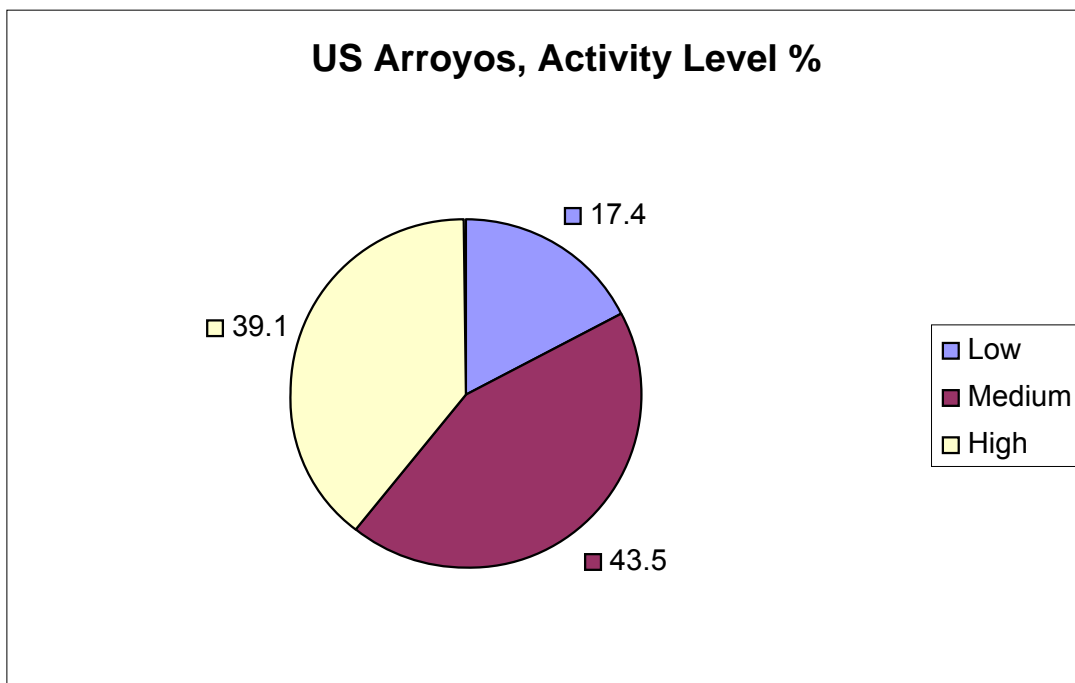
Figure 12 - Distribution by activity level, U.S.

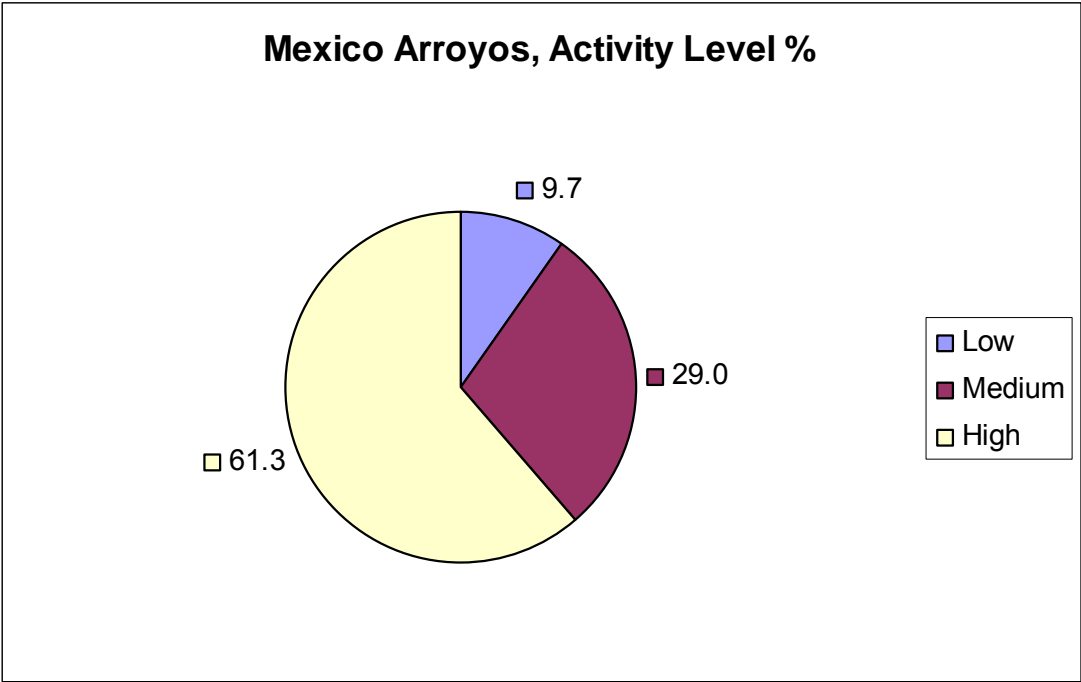
Figure 13 - Distribution by activity level, Mexico.

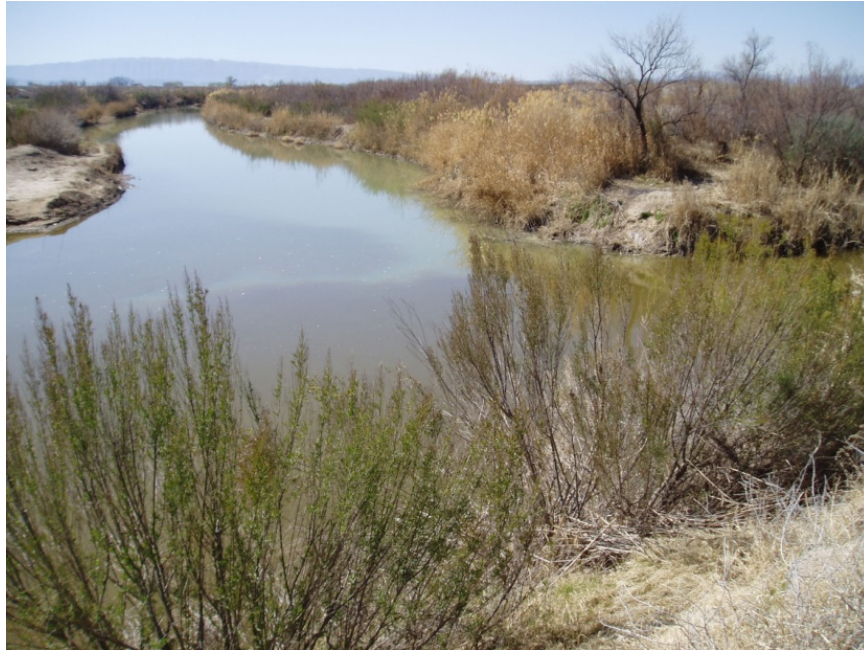
Figure 15 - Confluence of the Rio Grande (to the right) and Rio Conchos (to the left) in Presidio County, Texas. Photo taken January 2007.

The photograph taken below at the confluence of the Rio Conchos and the Rio Grande near Haciendita, Texas, above Presidio visually depicts the water quality issues in the Rio Grande, where the difference in the water clarity is visible as the rivers merge.

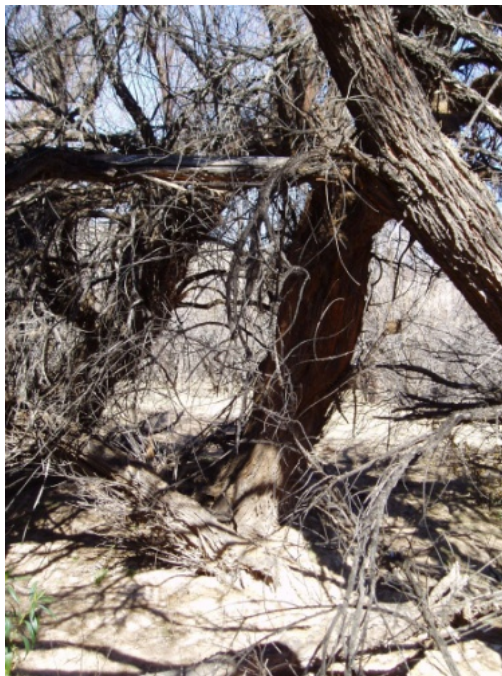
Figure 16 - Large old-growth saltcedar trees on the Green River Valley Ranch, exceeding 20" Diameter Breast Height; February 2007.

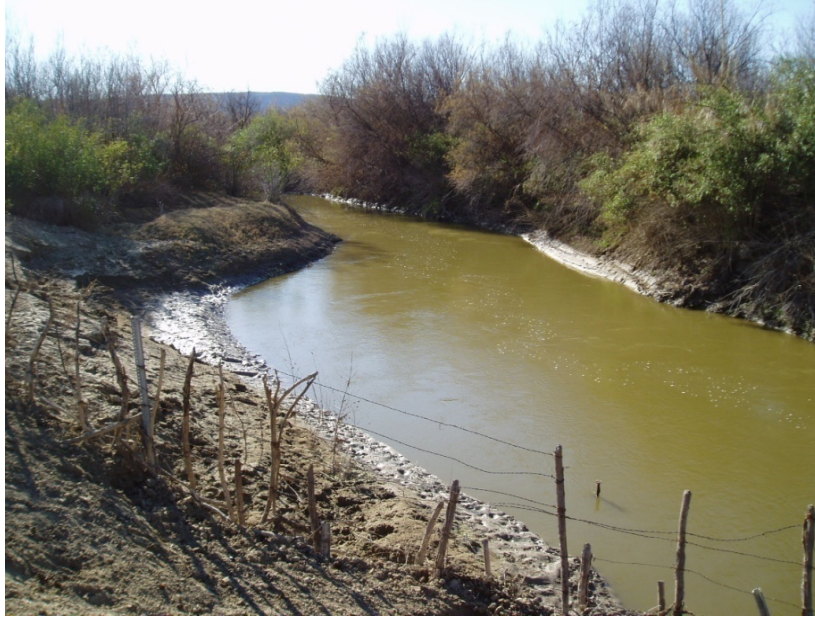
Figure 17 - The Rio Grande near Cecil's Pond Mitigation site - entrenched and displaying poor water quality, upstream of Haciendita, Texas looking downstream.

An indication of the difficulty of maintaining restoration plantings without an investment in periodic inspection and maintenance is given by the current status of the Cecil's Pond revegetation project of 1985. This revegetation effort was undertaken to partially mitigate for wildlife habitat losses incurred in construction and clearing activities on the Boundary Preservation Project of 1980 (Anderson and Ohmart 1986). A visit to the site by a Corps biologist and a Corps contractor on February 16, 2007, revealed poor survival of cottonwood and black willow plantings. Uncontrolled livestock grazing, drought, and channel incision and entrenchment appeared to be the main causes of planting failures observed, as less than 20 willows and ten cottonwoods were found to have survived on the 12 acre site, despite a planting effort of over 1,000 trees in 1985. Salinity of soil and surface and groundwater may have also contributed to the demise of plants.

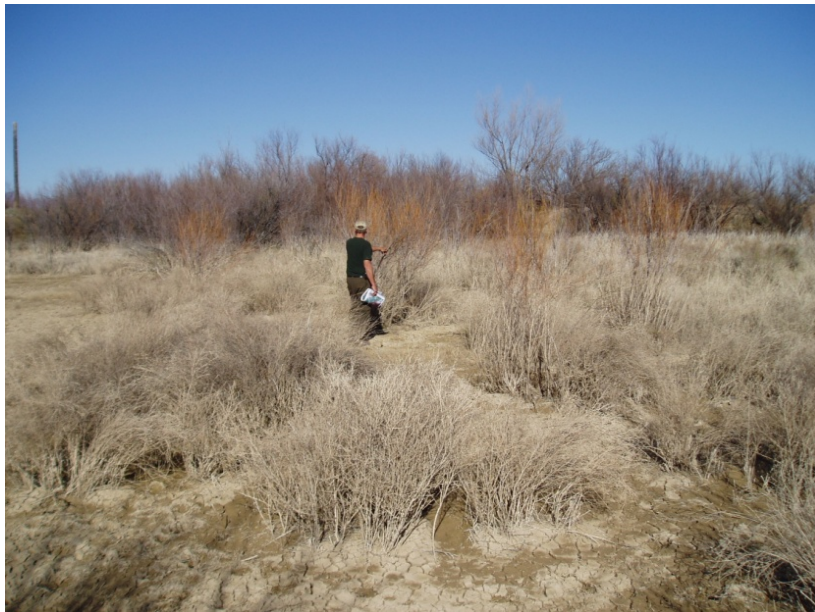
Figure 18 - A Corps' contractor examines the few remnants of over a thousand Cottonwoods and Willows that were planted in 1985 at Cecil's Pond Mitigation Site - Note the artificial snag placed in 1985 and still standing on the far left; 2007.

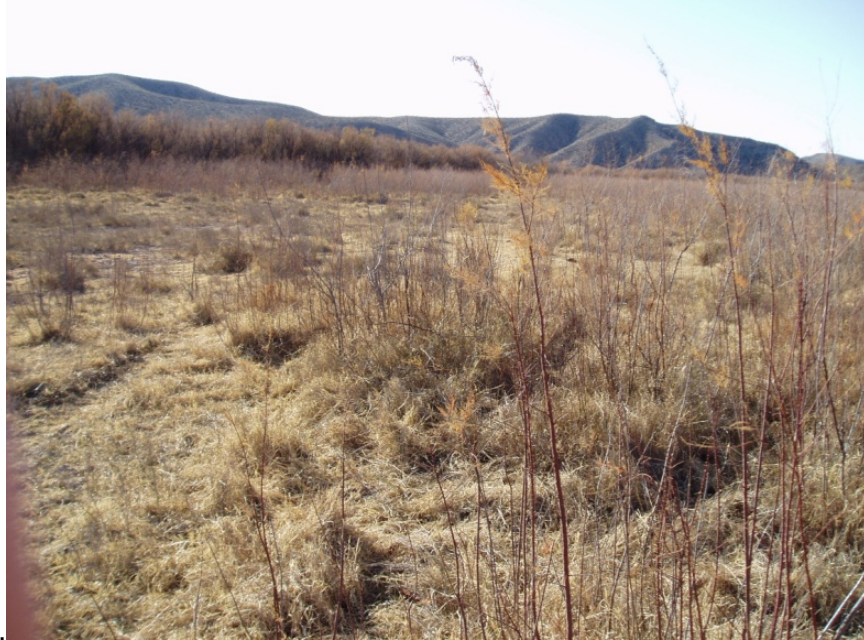
Figure 19 - A Bermuda grass pasture being colonized with Saltcedar in southern Hudspeth County, Texas; January 2007.
