Lead Cable Investigation

June 30, 2023

Tom Neltner
Environmental Defense Fund
1875 Connecticut Ave NW
Washington, D.C. 20009

Marine Taxonomic Services, Ltd.
Below the Blue 501(c)3

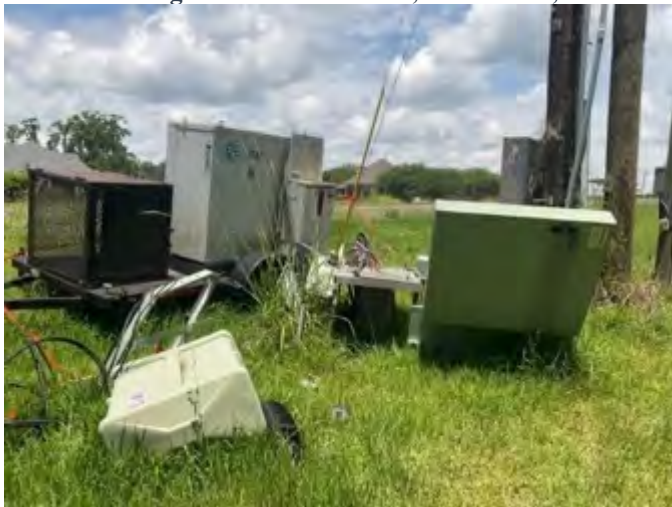
(D) Equipment debris field left by workers near the N Lewis Street Bridge. BT 16.1 June 2022, New Iberia, Louisiana.

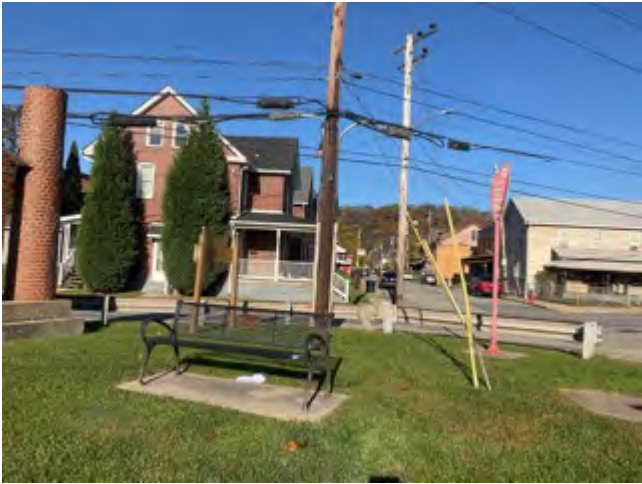
Aside from the overhead cable found within California Township (Coal Center), there were only two points along the Allegheny River where visible lead sheathed cable was recorded. AR 1 also, has a small portion of lead sheathed cable running up an old telephone pole near a personal watercraft boat launch, with a sitting bench (Figure 17(A-C)).

(A) Park bench near exposed lead sheathed cables and splice boxes. October 2022. Natrona, Pennsylvania.

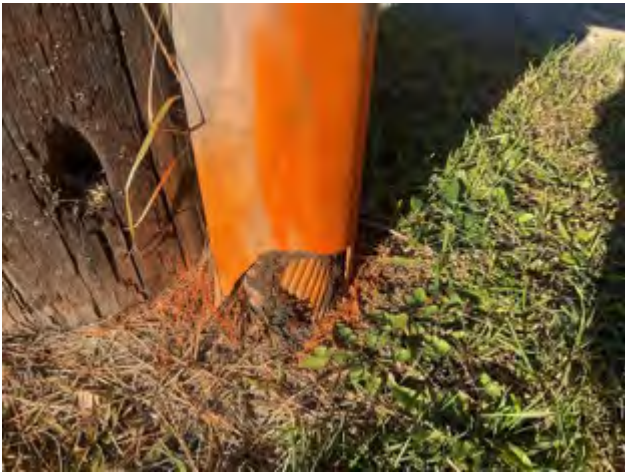
(B) Base of telephone pole in (A) and (C) showing marked cable going into the ground. October 2022. Natrona, Pennsylvania.

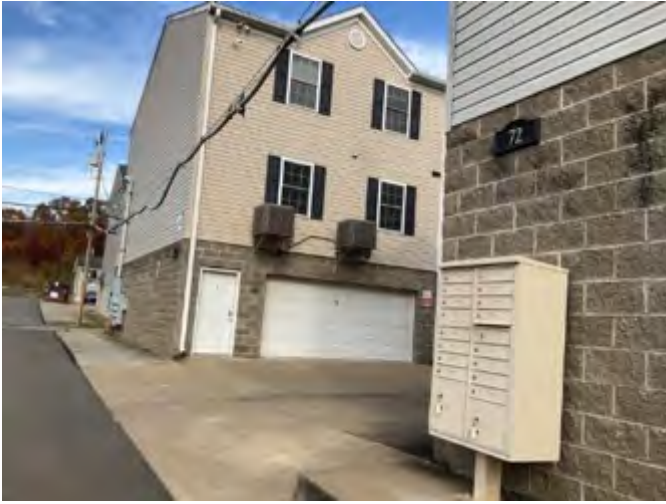
(D) CT6. Overhead lead sheathed cable running across the entrance into apartments and over access to mailboxes. February 2023. Coal Center, Pennsylvania.

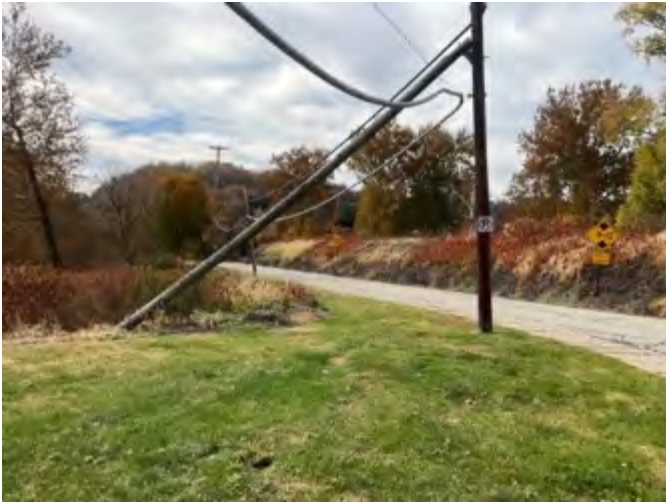
(E) CT8. Overhead lead sheathed cable running across a greenway and sidewalk. February 2023. Coal Center, Pennsylvania.

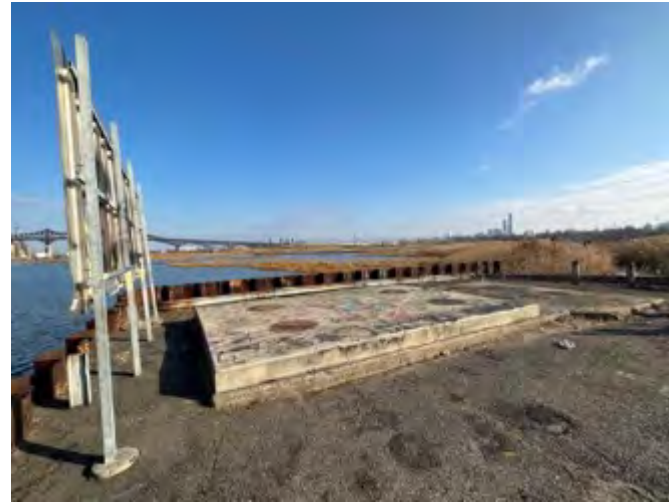
(C) Vault area looking towards Lincoln Park Wetlands & Nature Trail. January 2023, West Side, New Jersey.

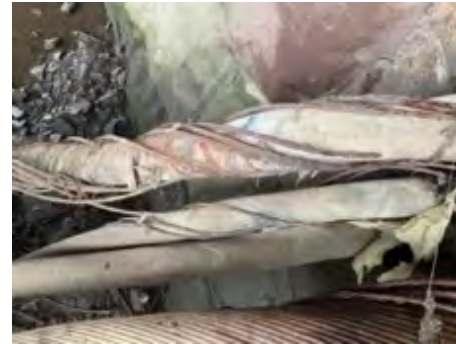
(K) Close up of cables at Passaic 8. January 2023. New Jersey.

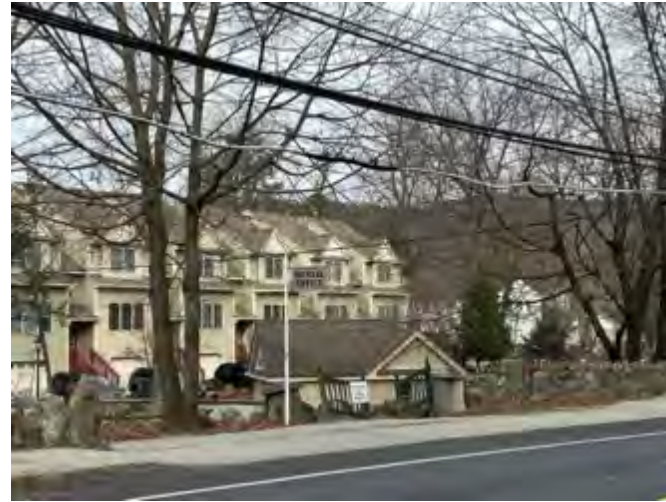
Four generalized data points were recorded for Highland Falls Township. Lead sheathed cable appears to run throughout the town and is occasionally covered with a protective sheathing that encompasses parts of the cable. Visible bare leaded splice boxes were observed at nearly every telephone pole. (Figure 25(A-C)). This site required more time than was available for detailed observations and further investigation is recommended.

(B) Overhead lead sheathed cables in front of an apartment complex. January 2023. Highland Falls, New York.

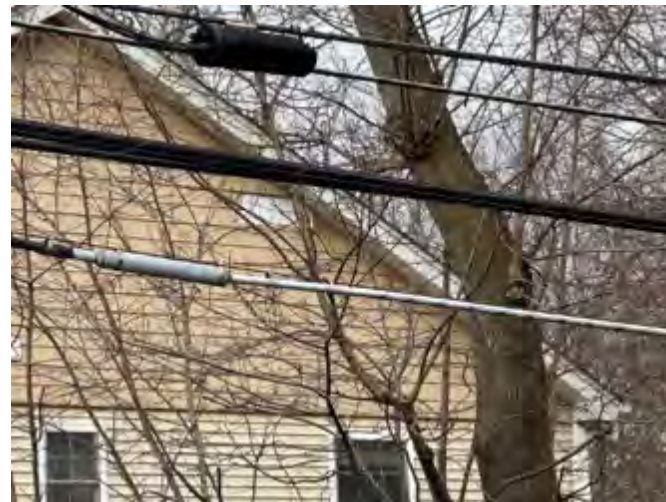
(C) Exposed bare lead splice box and lead cable. January 2023. Highland Falls, New York.

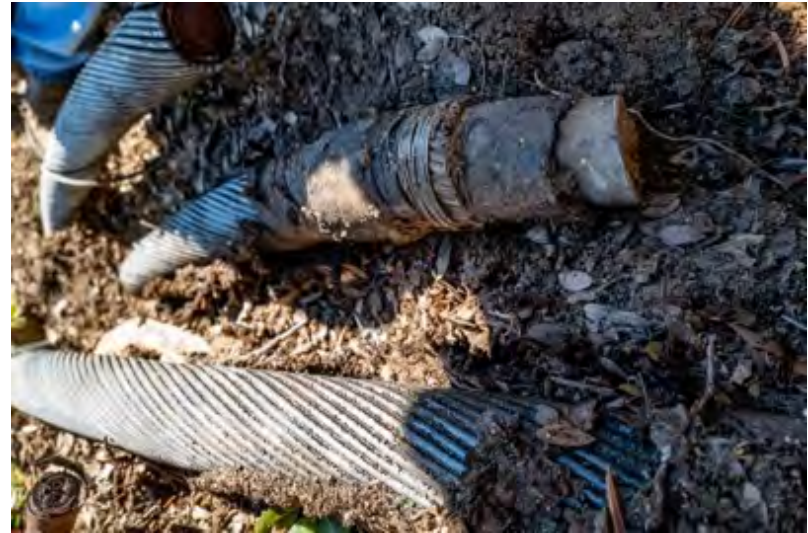
(B) Another splice location from land during the same site visit with AT&T in January 2021.
