Lead Cable Investigation

June 30, 2023

Tom Neltner
Environmental Defense Fund
1875 Connecticut Ave NW
Washington, D.C. 20009

Marine Taxonomic Services, Ltd.
Below the Blue 501(c)3

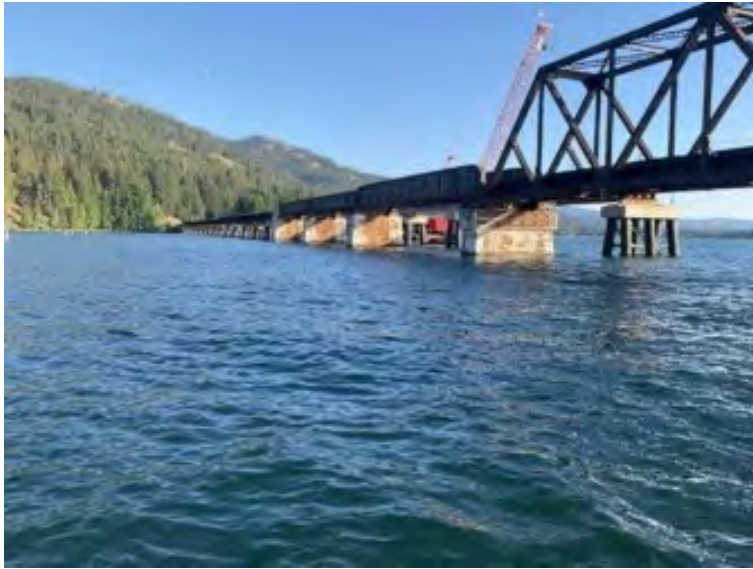
(A) Lake Pend Oreille, ID Railroad Bridge. August 2022.

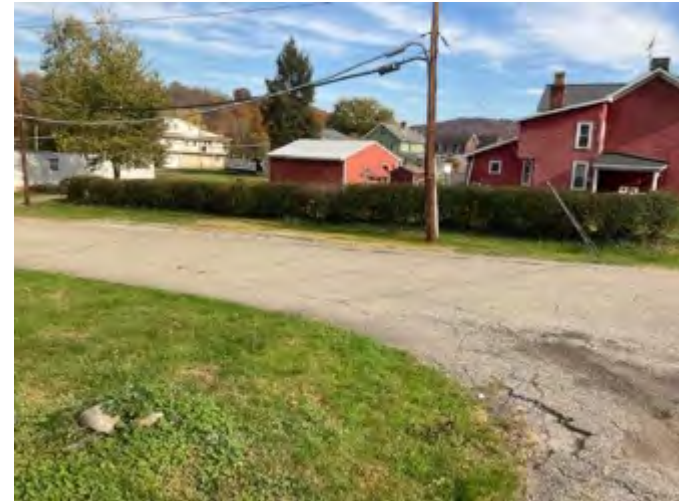
(G) CT12. Overhead lead sheathed cable running across the road next to homes. October 2022. Coal Center, Pennsylvania.

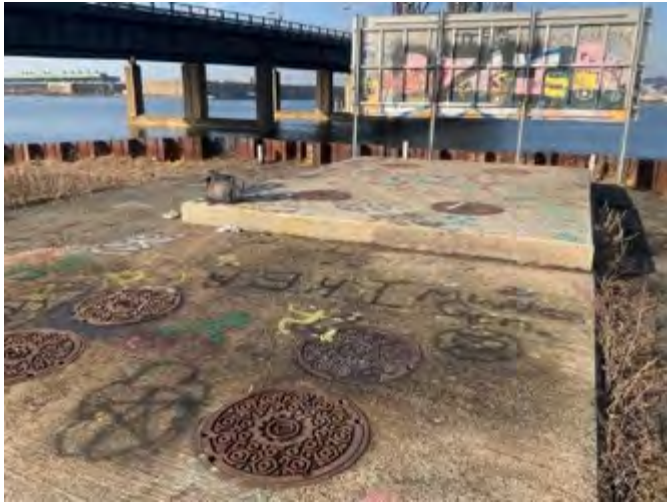
(A) Large vault with eight Bell Systems manholes on the Hackensack River. Looking towards South Kearny. January 2023, West Side, New Jersey.

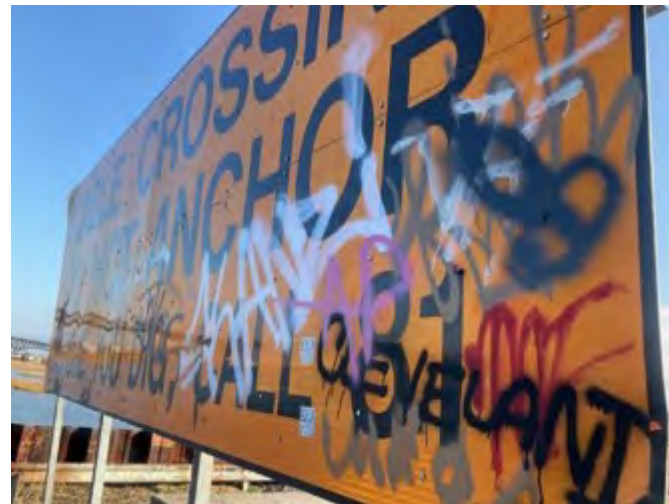
(D) Cable Crossing Sign. January 2023, West Side, New Jersey.

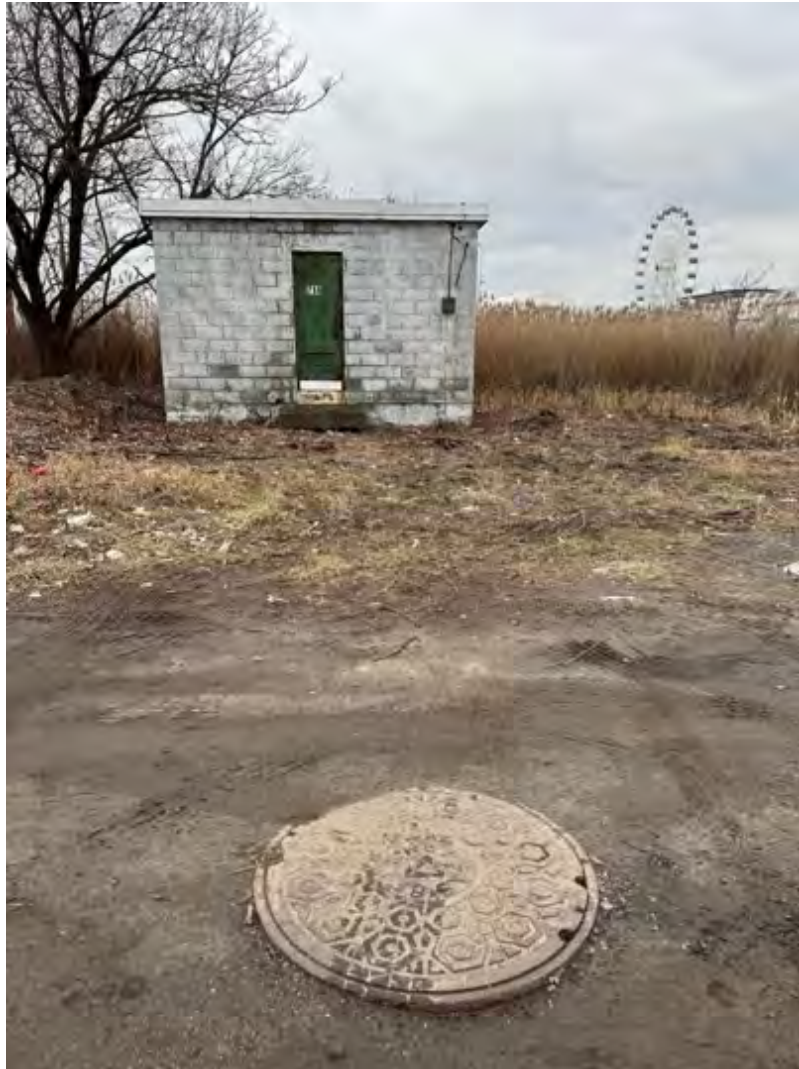
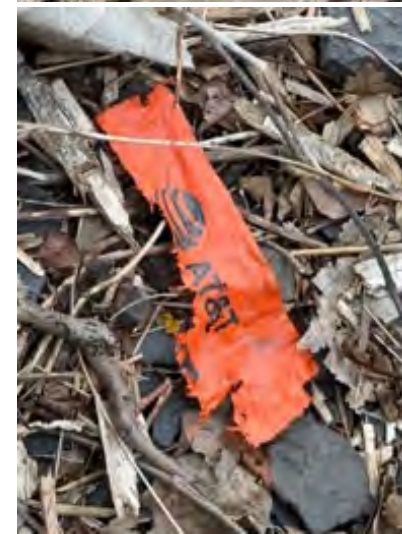
Figure 21. Photos. New Jersey continued. (E) Largely abandoned area around the Meadowlands. Old Bell Systems manhole and utility building. (F) Concrete casing that would have laid on top of the old lead sheathed cable. This is like those found on the Detroit River, Location 1. (G) Newer AT&T flagging found a few feet away from the building. Hackensack 3.2. January 2023, Meadowlands, New Jersey.
